SERVICE INFORMATION LETTER NO. SIL20C1-006

All DA20-C1 aircraft with a Continental Motors IO-240B engine.

Inspection and Maintenance of the throttle and mixture control arms installation.

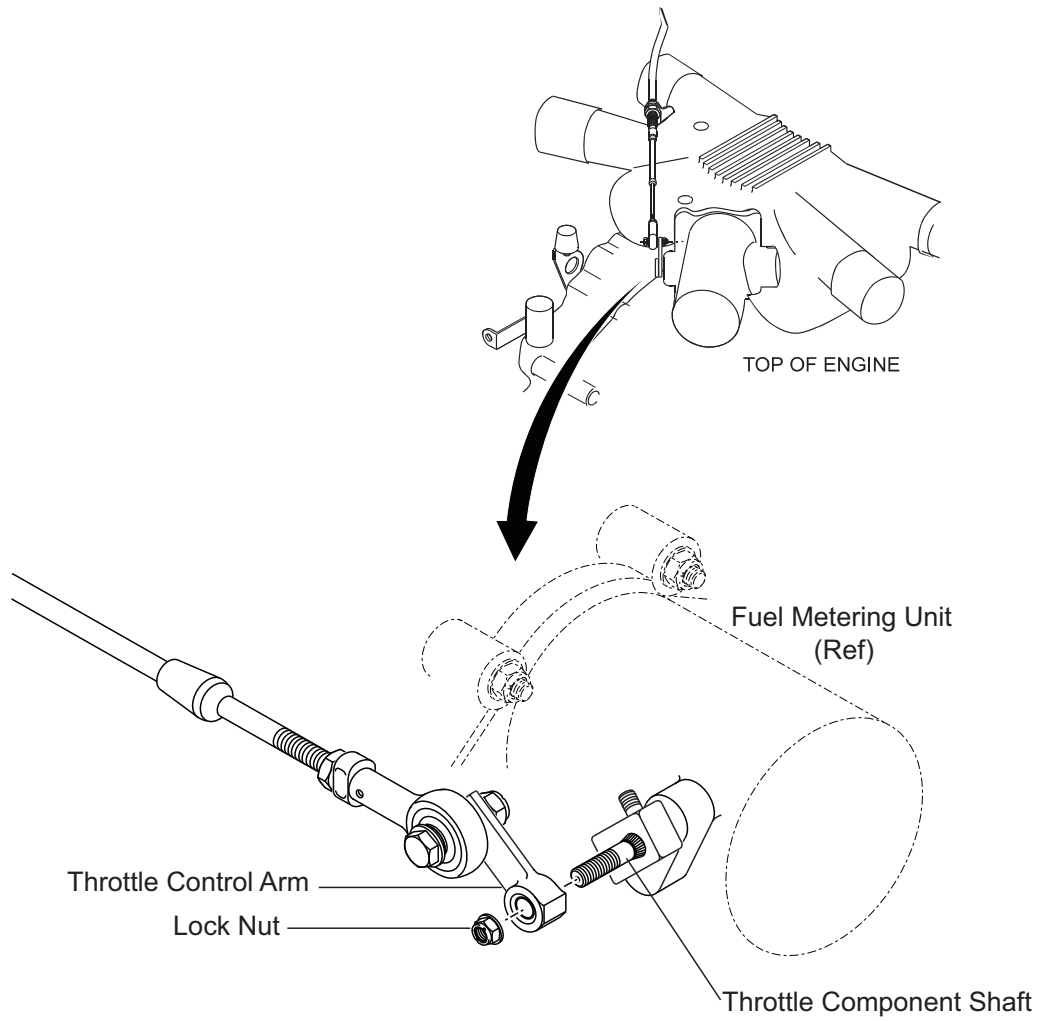
Figure 1 - Throttle Control Arm Installation

If the throttle and mixture control arms are not inspected for correct installation, it could result in a loss of throttle operation or degraded throttle operation.

A spline machined into the mating chamfer in the side of the throttle/mixture control arm must be interlocked with a chamfered spline machined onto the mating end of the throttle/mixture component shaft. The throttle component shaft is part of the Continental fuel metering unit. The mixture component shaft is part of the Continental fuel injector.

- 1.4.3 Carefully inspect the throttle/mixture control arm and the throttle/mixture component shaft.
 - Make sure that there are no cracked or stripped threads on the component shaft.

- Make sure that the serrations on the throttle/mixture control arm and the throttle/mixture component shaft are not chipped or worn.
 - If the throttle/mixture control arm is damaged, replace it.

- 1.4.1 Remove and discard the lock nut.
- 1.4.2 Remove the throttle/mixture control arm from the throttle/mixture component shaft and fuel metering unit/fuel injector.

- 1.4.4 Install the throttle/mixture control arm.
 - Lubricate the threads of the throttle/mixture component shaft lightly with clean 50 weight engine oil.

- Install the throttle/mixture control arm onto the throttle/mixture component shaft. Position the control arm to allow proper interface with throttle controls.

- Make sure that the serrations of the control arm are meshed as close as possible with the serrations on the component shaft.
 - Wet-Install a new lock nut. Torque the lock nut to 100-120 in. lbs., or to the latest torque provided by Continental Motors.

- Check the throttle/mixture control arm during torque application to make sure there is no free play or movement of the control arm on the throttle/mixture component shaft.

- Witness mark the lock nut to its position on the throttle/mixture component shaft.
- 1.4.5 Do an inspection of the engine control cables and linkage in accordance with Teledyne Continental Service Bulletin SB95-2, dated 21 May 1995 or latest applicable revision.
