SERVICE BULLETIN

Service Bulletin No.: D42L-34-03 Rev 2

Title: ADF System Improvements

- 1. ATA Code:** 3450
- 2. Effectivity:** All DA42 aircraft with Transport Canada Civil Aviation (TCCA) STC SA09-54 or Federal Aviation Administration (FAA) STC SA02725NY installed.
- 3. General:** This Service Bulletin (SB) gives instructions for overall improvements of the ADF System installed on the aircraft. There are three options available.

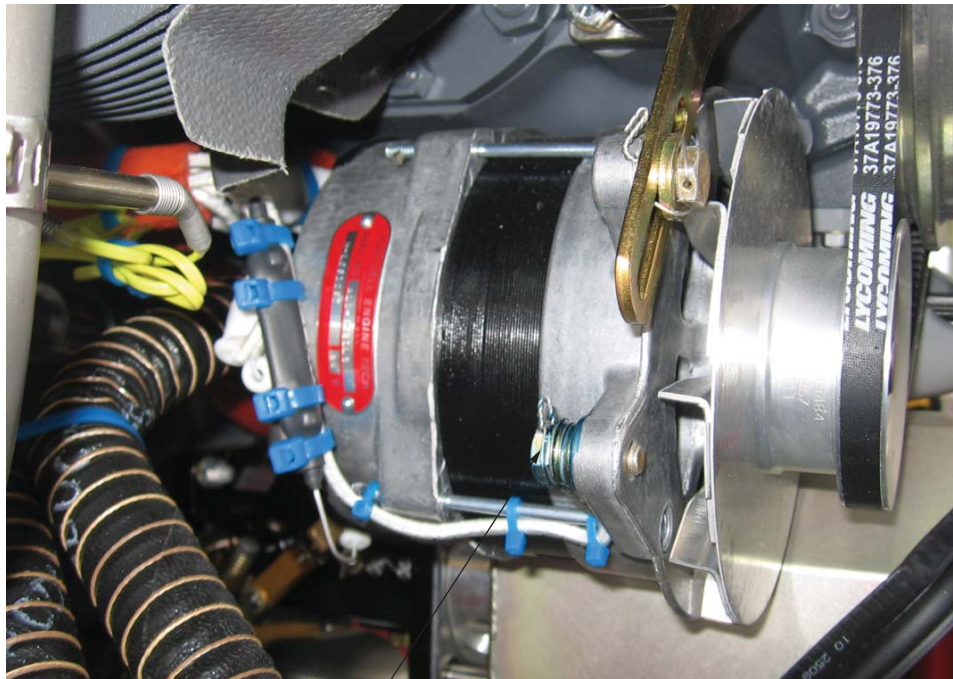
Figure 1

Remove bolt and clean

- 10.1.1 Disconnect the aircraft battery. Refer to the DA42 AMM Document No. 7.02.01 Chapter 24-31.
- 10.1.2 Remove the Left Hand (LH) side and Right Hand (RH) side engine top cowling. Refer to the AMM Document No. D42L-AMM-001 Chapter 71-10.
- 10.1.3 Disconnect the LH alternator cable at the LH alternator.
- 10.1.4 Remove the alternator ground bolt and clean area with isopropyl alcohol for grounding connection. Refer to Figure 1.
