1. **ATA Code:** 3450

2. **Effectivity:** All DA42 aircraft with TCCA STC SA09-54 or FAA STC SA02725NY installed with Garmin GIA 63W (WAAS).

3. **General:** This Service Bulletin enables installation of the Garmin GTX 33ES Extended Squitter Modes S transponder, providing ADS-B Out compliance to TSO C166b.

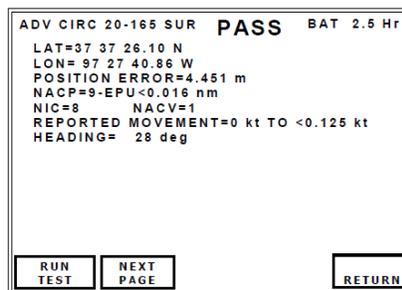
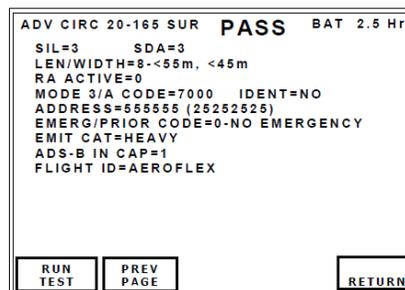
10.7.3 Select the 'ADV CIRC' test option and run the 'AC 20-165 SURFACE' test. Verify that PASS is displayed on the IFR6000 screen when test is completed.

(Example screen shots)
