SERVICE INFORMATION NO. SI 20E-004

Rotax Alert Service Bulletin ASB-912 i-007
ATA-Code: 24-20

ALERT SERVICE BULLETIN

Checking of the correct positioning of sealing plug in ignition housing for ROTAX® Engine Type 912 i (Series)

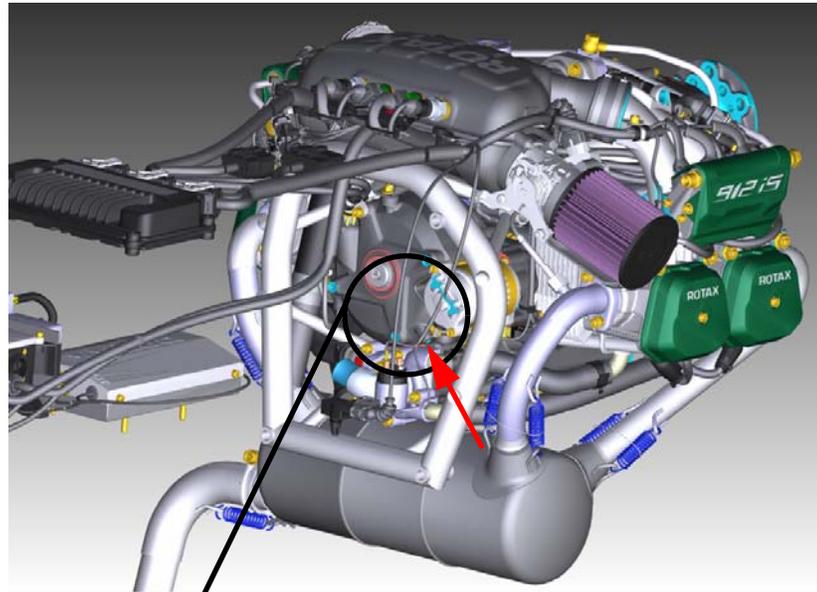
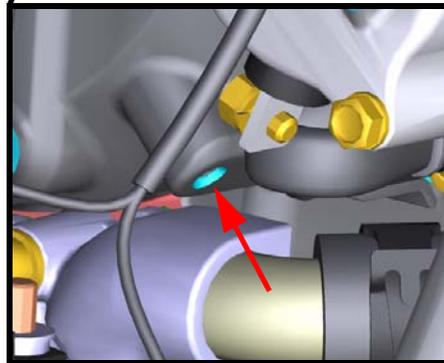
Fig. 1
Sealing plug in ignition housing

Field observation has shown that in isolated cases the sealing plug (see Fig. 1) was not pressed to its correct seating position in the ignition housing. In rare cases this may lead to loss of oil and subsequently loss of lubrication which leads to engine stoppage.

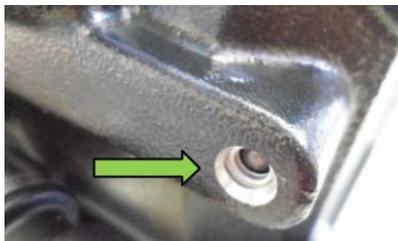
Sealing plug position "OK"

Step	Procedure
1	Check the position of sealing plug in the relevant area of ignition housing assy. See Fig. 2.
2	The sealing plug must show to have been pressed in until the top of the ball is below the edge of the sleeve. See position OK in Fig. 2.
3	If you notice sealing plug position is OK, then there is no need for further procedures. NOTE: If you notice sealing plug position is NOT OK, then see section 3.2.
