## SERVICE INFORMATION NO. SI 20E-008

EASA Emergency Airworthiness Directive 2019-0055-E  
Rotax Alert Service Bulletin ASB-912 i-010iS

## ATA 73 – Engine fuel and Control – Fuel Pump Assembly – Inspection / Replacement

## Inspection and/or replacement of fuel pump assy. for ROTAX® Engine Type 912 i and 915 i A (Series)

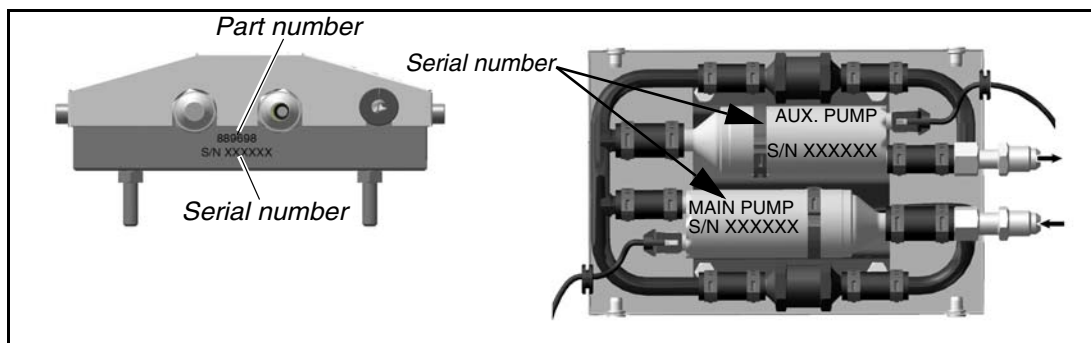
See Fig. 1 on information how to find the part no. and S/N on the fuel pump assy.

Step	Procedure
1	Loosen 4 Allen screws M5x12 and remove the cover.
2	Visually inspect area (1) for signs of fuel weep/leakage. If no visual signs are observed, proceed to following steps. If fuel leakage is observed proceed to section 3.3 Replacement of fuel pump assy.

Step	Procedure
10	If there is NO indication of any fuel leakage, no further action required for this fuel pumps assy. NOTE: If there is an indication of fuel leakage (e.g. Talcum shows fuel leakage coloring/wet spot) then see section 3.3)
11	Fix the cover with 4 Allen screws M5x12. See <a href="#">Fig. 1</a> . Tightening torque 6 Nm (53 in. lb).

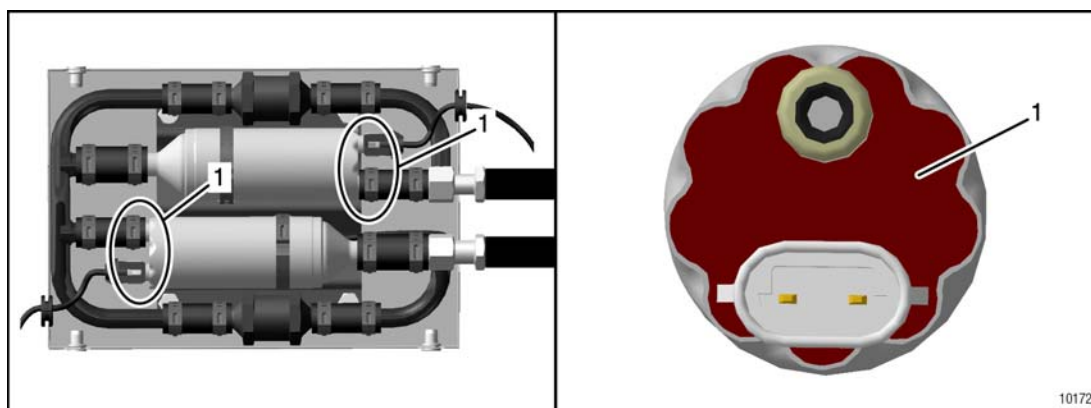
Fig. 2

Internal quality checks have shown that in isolated cases, there may be fuel leakage in the front end area of the power connector side. This may lead to a hazardous condition.

Step	Procedure
3	Clean the test area of the fuel pump assy.
4	Detailed leak detection in the area (1) of the fuel pumps (main, aux). Apply leak detection compound (e.g. hygroscopic powder like talcum or equivalent).

1 Area required detailed leak detection

**NOTICE** In case of fuel leakage during testing (e.g. talcum shows fuel leakage coloring/wet spot), turn both fuel pumps "OFF" and terminate inspection. Proceed to section 3.3 Replacement of fuel pump assy.

Step	Procedure
1	Replace fuel pump assy. by a new one, which is not affected by this ASB as per S/N range in Chapter 1.
