SERVICE INFORMATION NO. SI 20E-010

EASA Emergency Airworthiness Directive No. EAD 2019-0253-E Engine fuel and Control – Fuel Pump Assembly – Replacement

Rotax Alert Service Bulletin No. ASB-912 i-011, Replacement of Fuel Pump Assy for Engine Types 912 i and 915 i A (Series)

Replacement of fuel pump assy. for ROTAX® Aircraft Engine Type 915 i A and 912 i (Series)

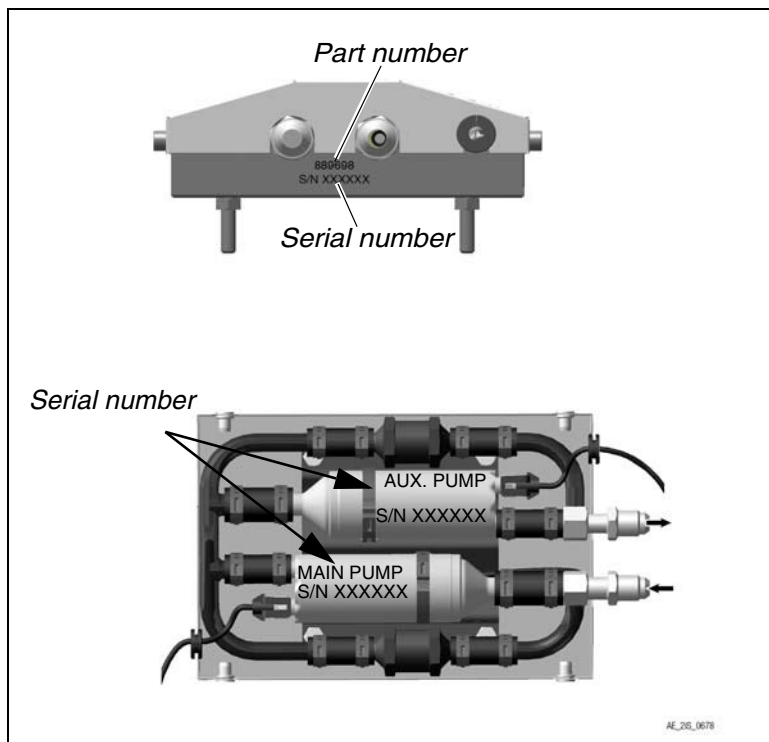
See Fig. 1 on information how to find the part no. and S/N on the fuel pump assy.
