SERVICE INFORMATION NO. SI 20E-011

GARMIN Service Bulletin No. 2082 Rev. A

NO.: 2082 Rev A

TO: All Garmin Aviation Service Centers
DATE: July 2, 2020
SUBJECT: GTN 6XX/7XX GPS Date

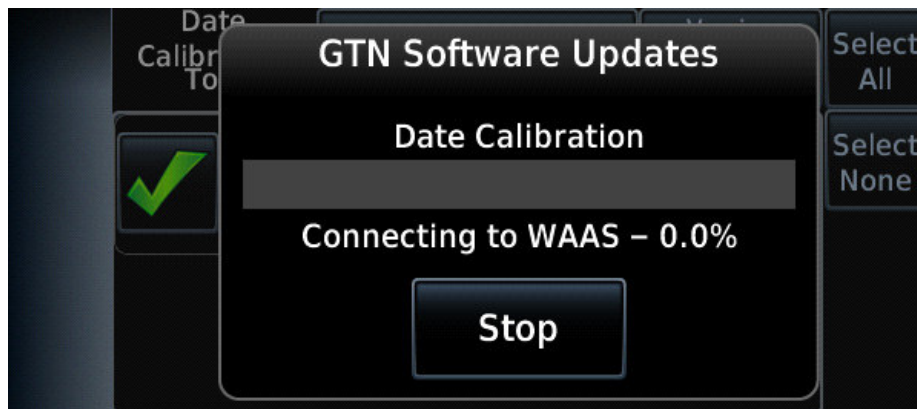
Figure 4. Connecting to WAAS

The GTN will indicate it is attempting to connect to the GPS/WAAS receiver. This may take up to 45 seconds.

7. If the calibration fails at this step, go back to Step 4.

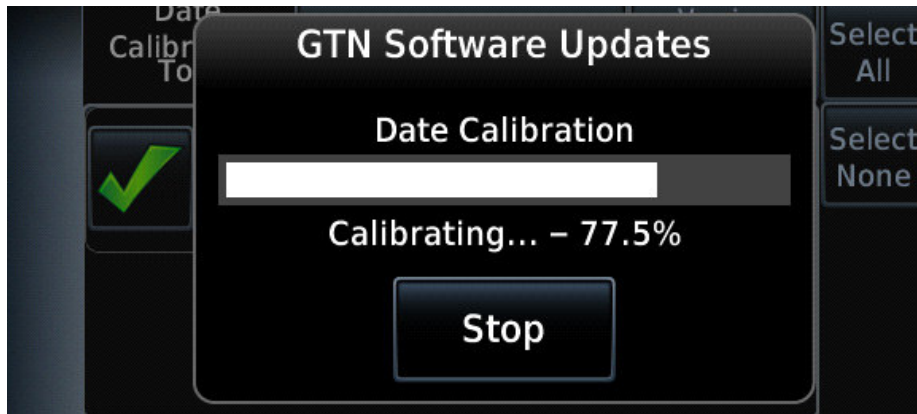
Figure 5. Date Calibration

Once the connection is established, the tool will calibrate the date.
