SERVICE INFORMATION

NO. SI 20E-016

BRP-Rotax GmbH & Co KG Service Bulletin SB-912 i-015
ATA-Code: 75-20

Inspection and/or replacement of expansion tank assy. for ROTAX® 912, 914, 912 i, 915 i and 916 i (Series) Aircraft Engines

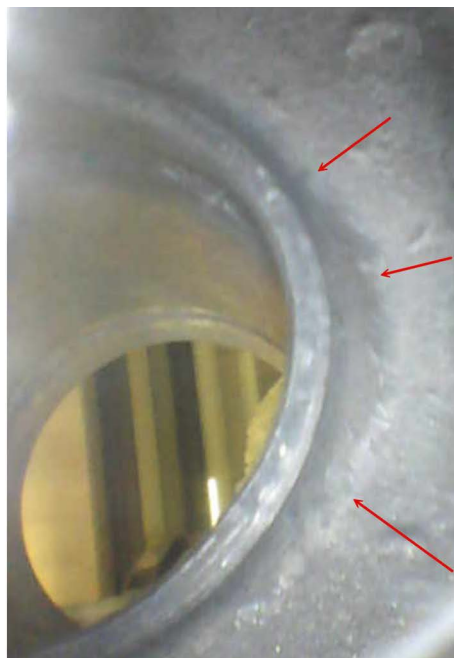
Step	Procedure
1	Remove the radiator cap from the expansion tank.
2	Perform an internal visual inspection using a bore-scope or similar device.
3	If the visual inspection shows consistent welding, the expansion tank assy. is serviceable (See Fig. 5), continue with section 3.6). NOTE: Welding must be present and contiguous around every connection.
4	If the visual inspection shows any connection with inconsistent or missing welds, the expansion tank assy. is unserviceable and must be replaced (See Fig. 6).
5	Apply small amount of coolant to rubber surfaces inside radiator cap (provides lubrication to prevent binding). Tighten the radiator cap by hand.

Fig. 5: GOOD Welding – total view / GOOD Welding – side view

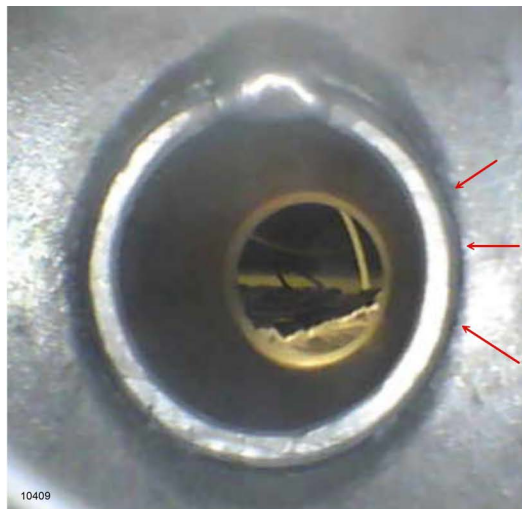
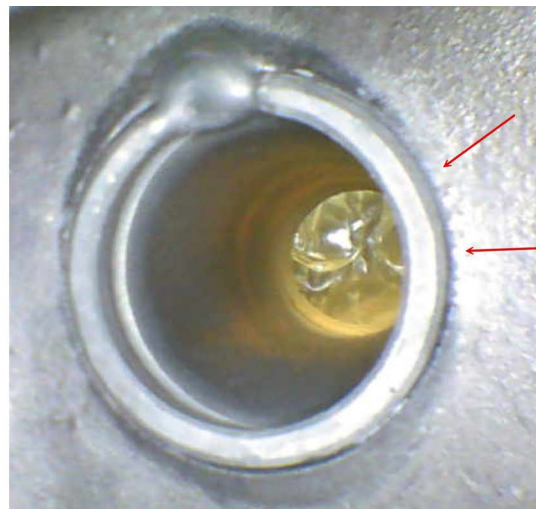
Due to a deviation in the manufacturing process, the individual components of the expansion tank assy. may not be sufficiently welded. Sealing of the assy. may be compromised and coolant leakage and subsequently an overheating of the engine may occur.

Fig. 6: BAD Welding – total view / BAD Welding – side view
