RECOMMENDED SERVICE BULLETIN RSB 40NG-011

Type: DA 40 NG

Exchange of charged air elbow

WI-RSB 40NG-011

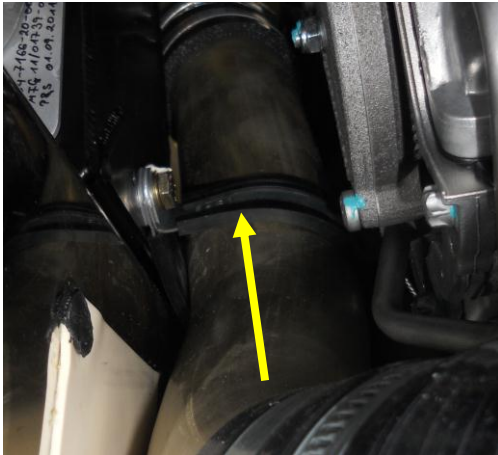
Figure 1: Attachment of charged air tube

1	Make sure AMM-TR-MÄM 40-502 & AMM-TR-MÄM 40-506 has been incorporated into the AMM.
2	Remove cowlings (refer to AMM section 71-10). WARNING DO NOT STAND WITHIN THE DANGER AREA OF THE PROPELLER. IF THE ENGINE STARTS THE PROPELLER CAN CAUSE DEATH OR INJURY TO PERSONS. WARNING MAKE SURE THAT THE ENGINE IS SAFE BEFORE YOU WORK ON THE ENGINE CONTROLS. IF THE PROPELLER TURNS IT CAN CAUSE INJURY TO PERSONS.
3	Remove charged air elbow.
4	Remove Turbo adapter D44-8126-70-01 from turbo charger.
5	Remove P-clamp which holds the charged air tube on the air filter box.

6	Install screw DIN 933-M8x16-YZP with previously installed washer on air filter box, where the P-Clamp was attached before.
7	Install charged air hose D44-8126-00-08 on charged air tube (refer to SI 40NG-007). CAUTION DO NOT TIGHTEN THE WORM DRIVE CLAMPS WITH THE ENGINE BEING HOT. THIS CAN DAMAGE THE SILICONE HOSES AND MAY RESULT IN LOSS OF ENGINE POWER.
8	Install Turbo Connector D44-8122-20-00 with O-ring (refer to SI 40NG-007). Make sure the charge air tube must have at least 5 mm clearance from the firewall and positive clearance to the coolant tube aft of the engine (refer to figure 2).

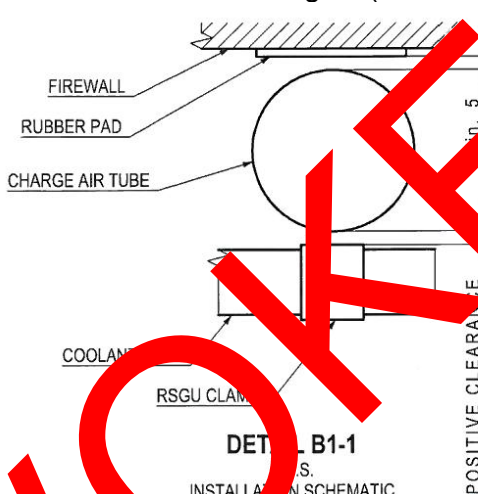
Figure 2: Clearance of charged air tube CAUTION DO NOT TIGHTEN THE WORM DRIVE CLAMPS WITH THE ENGINE BEING HOT. THIS CAN DAMAGE THE SILICONE HOSES AND MAY RESULT IN LOSS OF ENGINE POWER.
9	Clean working area, check for foreign objects.
10	Check all altered, replaced, repaired parts for proper function.
