MANDATORY SERVICE BULLETIN

MSB 40NG-018/1

Exchange of charged air tubing.

WI-MSB 40NG-018

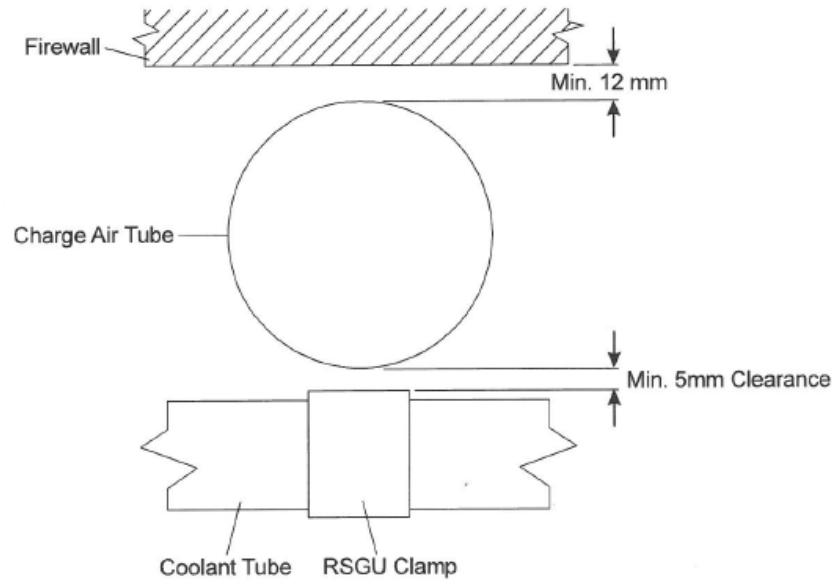
Figure 1: Clearance between charge air tube to firewall and coolant tube

Leakages of the charge air tubing due to improper installation and maintenance as well as chafing of aluminum tubing on the firewall because of small clearances making the installation critical required a new design providing more clearance. This service bulletin describes the retrofit installation of the new design.

- Make sure that the charge air tube has at **least** 12 mm clearance to the firewall and at **least** 5 mm clearance to the coolant tube aft of the engine (refer to Figure 1 and 2 below).
