# MANDATORY SERVICE BULLETIN

## MSB 40NG-046/2

Type: DA 40 NG

Inspection of turbocharger V-clamp.

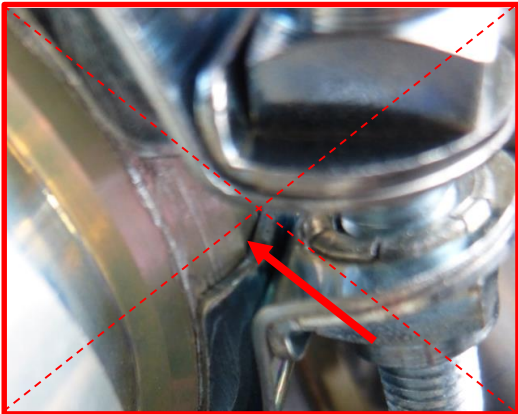
1	Make sure AMM-TR-MÄM-40-853/b is incorporated into the AMM.
2	Make sure the airplane is safe.
3	Remove the cowling i.a.w. AMM Section 71-10.
4	<p>Inspect the V-clamp (all V-Clamp P/Ns) on the pressure side of the turbo-charger:</p> <ul style="list-style-type: none"> <li>Inspect for positive clearance between the flanges of the turbocharger/aluminium charged air tube and the base of the V-clamp on the complete circumference. If there is NO positive clearance (refer to Figure 1) replace the V-clamp i.a.w. Section III.2. Refer to Figures 1 and 2.</li> </ul> <div data-bbox="306 801 475 1169" style="border: 1px solid red; padding: 5px; margin: 10px 0;"> <p><b>NOT acceptable</b>        (NO positive clearance,        contact to the base)</p> </div> <div data-bbox="708 766 1228 1178" style="border: 1px solid red; margin: 10px 0;">

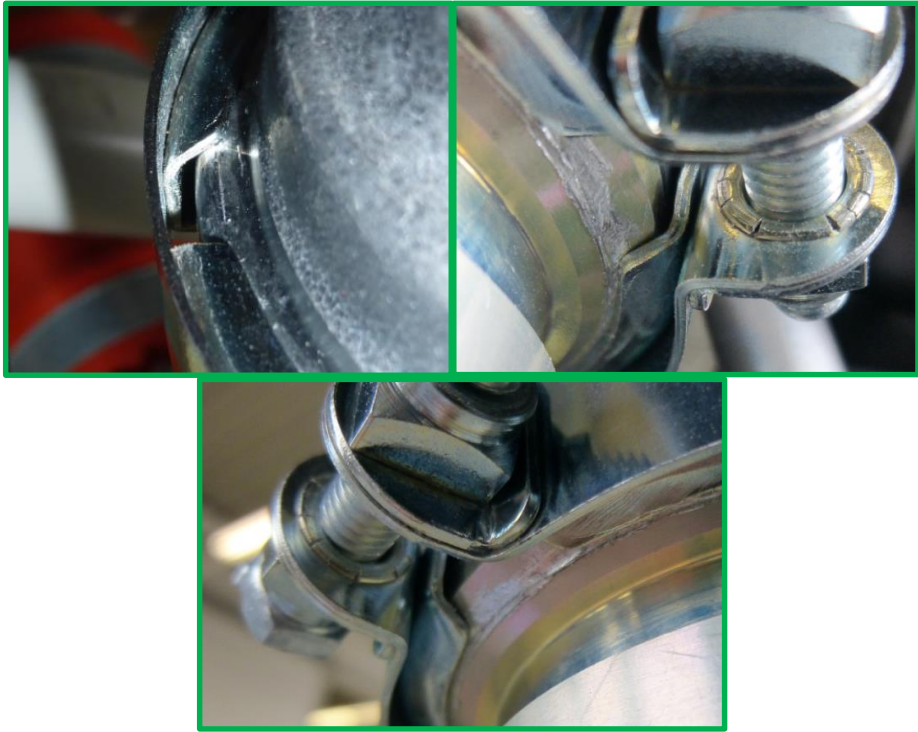
</div> <div data-bbox="890 1975 1005 2011" style="text-align: center;"> <p>Figure 2</p> </div>

</div> <div data-bbox="909 1178 1021 1214" style="text-align: center;"> <p>Figure 1</p> </div> <div data-bbox="293 1245 434 1975" style="border: 1px solid green; padding: 5px; margin: 10px 0;"> <p><b>Acceptable installations</b>        (positive clearance, NO contact)</p> </div> <div data-bbox="485 1245 1407 1975" style="border: 1px solid green; margin: 10px 0;">

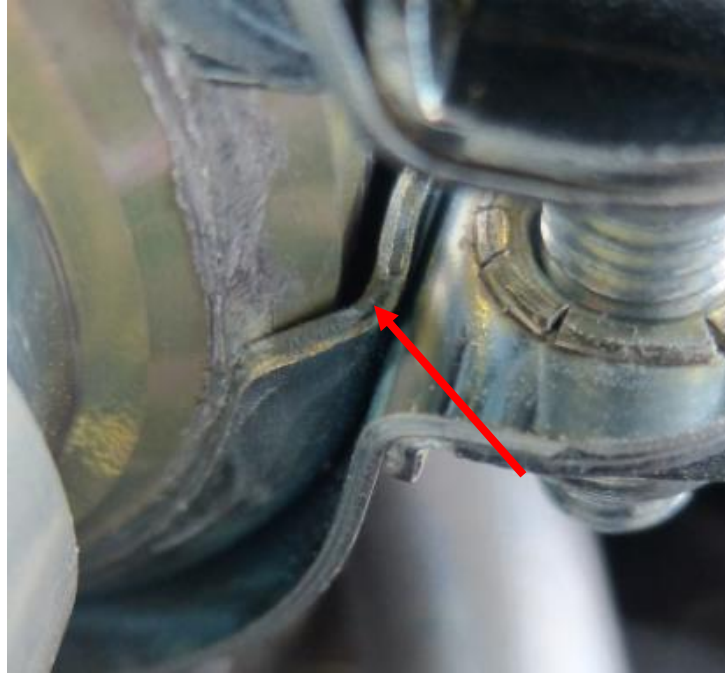
Figure 3

- Inspect for signs of cracks in the edges of the ends of the V-bands of the V-clamp with flashlight and mirror. If signs of cracks are detected, replace the V-clamp i.a.w. Section III.2. Refer to Figure 3.

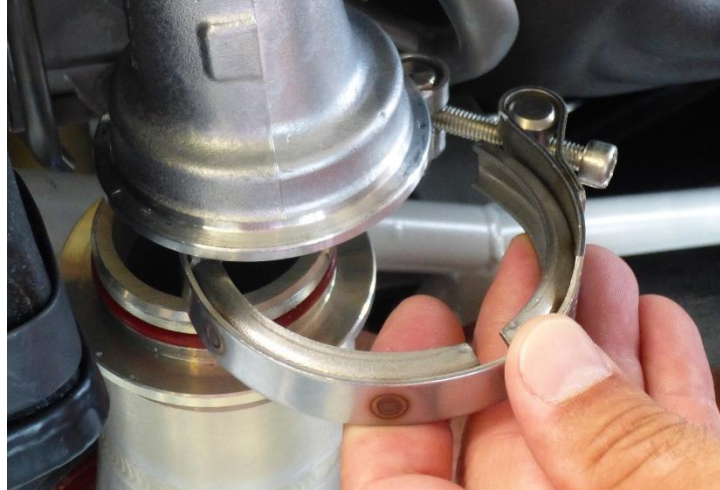
Figure 8

Note Do not pull the V-clamp over the turbocharger tube since the V-clamp will be permanently deformed. Refer to Figure 8.
