MANDATORY SERVICE BULLETIN

MSB 40NG-048/2

Type: DA 40 NG

Inspection of autopilot bridle cable clamps.

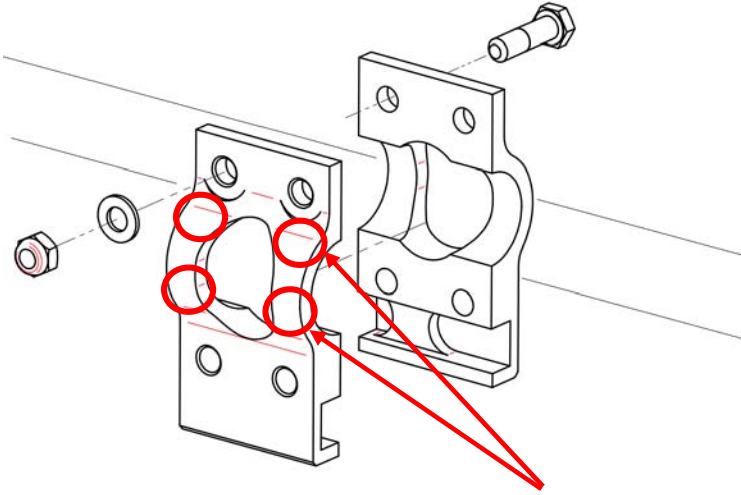
Cracked autopilot bridle cable clamps (P/N D41-2213-10-53 and P/N D41-2213-10-54) in the pitch and roll control system due to possible over-torqueing have been discovered during inspection. Tests have shown that the cracked clamps still perform their function but for safety reason they have to be inspected. This Service Bulletin describes the inspection of the clamps on the potentially affected airplanes.

| 3 | <p>Examine the clamps of the bridle cables for the pitch and roll servo:</p> <ul style="list-style-type: none"> • Carefully inspect the clamps with a bright light and a mirror for signs of cracks or damage. Use a magnifying glass, if necessary. • Inspect the upper and lower boltings for loose parts and damage. • Re-torque the bolts. <ul style="list-style-type: none"> ○ Mark the clamp position with witness paint or equivalent to allow confirmation that the clamp did not move while re-torqueing ○ Loosen one bolt at each time and tighten with 3.6 Nm (2.65 lb ft). <ul style="list-style-type: none"> ▪ Use a new self-locking nut. ▪ Start with the lower bolts. Make sure the lower surfaces touch. ○ Proceed with the remaining bolts. ○ Confirm that the clamp did not move. <p style="text-align: center;">Look especially in the marked areas for cracks.</p> <p>CAUTION: Use a torque wrench with an appropriate torque range. Apply the given torque carefully and do not overtorque the bolts as over-torquing the bolts might damage the autopilot cable clamps.</p> |

| 4 | <p>If a clamp has to be replaced:</p> <ul style="list-style-type: none"> • Replace the affected clamp. • Adjust the bridle cable tension i.a.w. AMM Section 22-10. • Torque the bolts with 3.6 Nm (2.65 lb ft). <p>CAUTION: Use a torque wrench with an appropriate torque range. Apply the given torque carefully and do not overtorque the bolts as over-torquing the bolts might damage the autopilot cable clamps.</p> <p>Note: If a pair of autopilot bridle cable clamps P/N D41-2213-10-53_02 and P/N D41-2213-10-54_02 is installed the 2 short bolts must be replaced with bolts P/N LN 9037-M5x28.</p> |

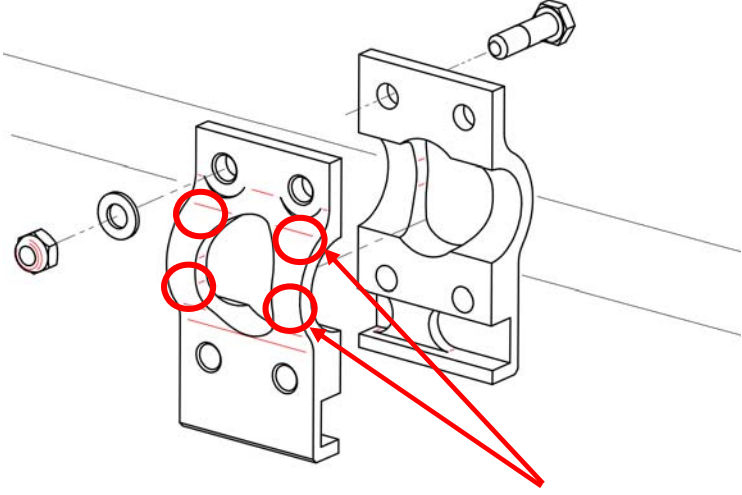
| 3 | Examine the clamps of the bridle cables for the pitch and roll servo: <ul style="list-style-type: none"> • Carefully inspect the clamps with a bright light and a mirror for signs of cracks or damage. Use a magnifying glass, if necessary. • Inspect the upper and lower boltings for loose parts and damage. <div style="text-align: center;"> <p>Look especially in the marked areas for cracks.</p> </div> <p>Note: Do not re-torque the bolts during recurrent inspection.</p> |

| 4 | <p>If a clamp has to be replaced:</p> <ul style="list-style-type: none"> • Replace the affected clamp, • Adjust the bridle cable tension i.a.w. AMM Section 22-10, • Torque the bolts with 3.6 Nm (2.65 lb ft), <p>CAUTION: Use a torque wrench with an appropriate torque range. Apply the given torque carefully and do not overtorque the bolts as over-torquing the bolts might damage the autopilot cable clamps.</p> <p>Note: If a pair of autopilot bridle cable clamps P/N D41-2213-10-53_02 and P/N D41-2213-10-54_02 is installed the 2 short bolts must be replaced with bolts P/N LN 9037-M5x28.</p> |
