# RECOMMENDED SERVICE BULLETIN RSB 40NG-052

Type:DA 40 NG,Serial numbers:40.N001 through 40.N323Applies to all aircraft equipped with OÄM 40-314 additional<br/>alternator.

Improved mounting of 2nd Alternator.

# WORK INSTRUCTION WI-RSB 40NG-052

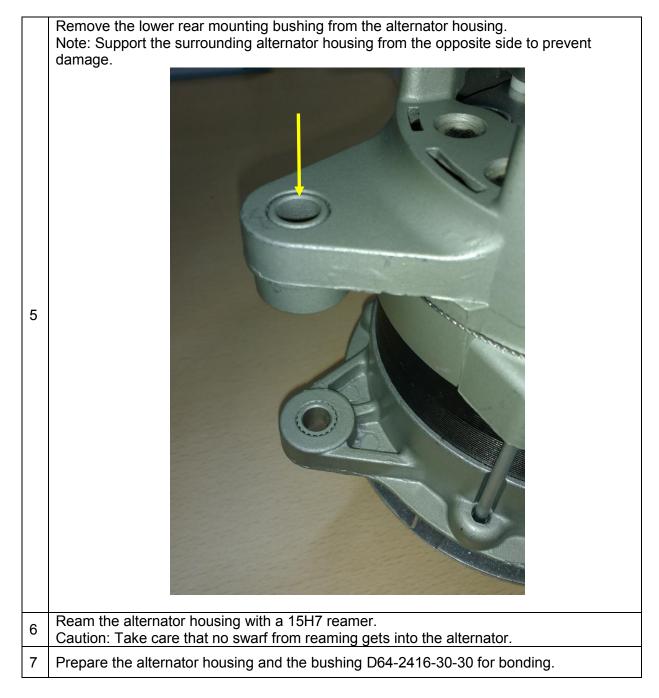
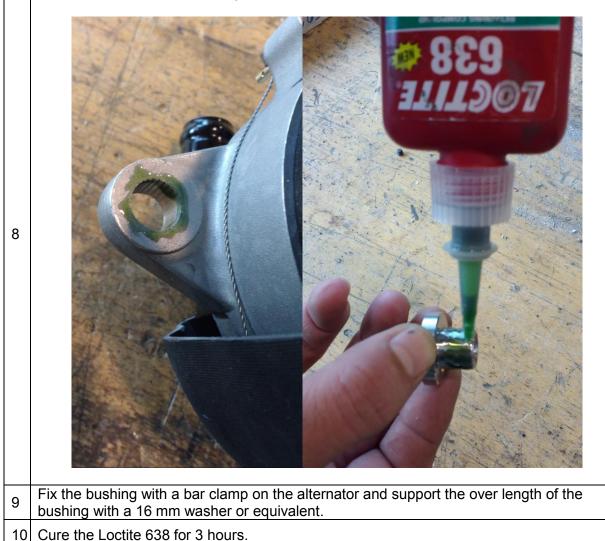
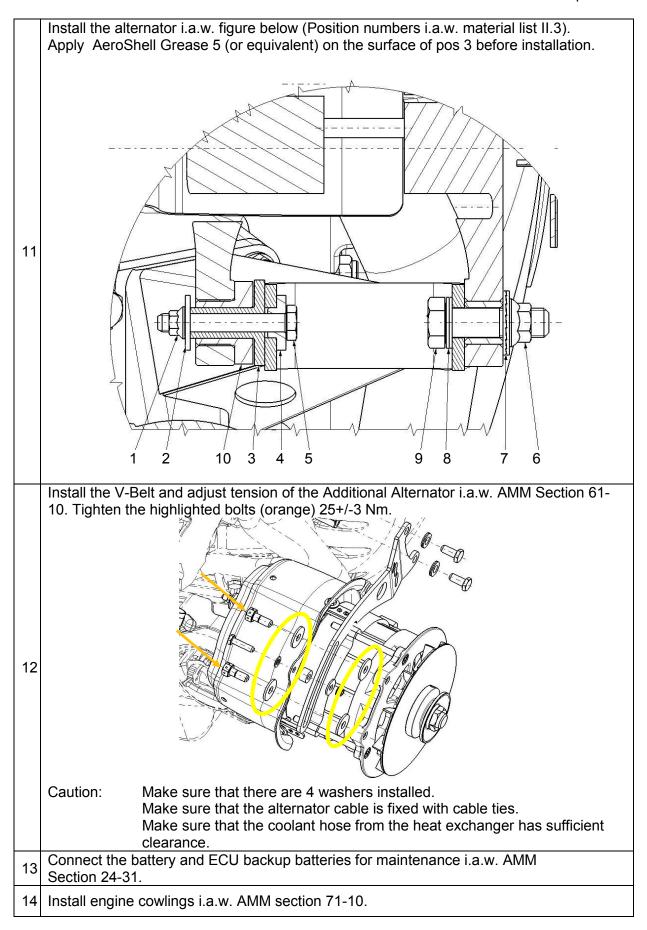
In order to reduce wear on the mounting arm, this Service Bulletin describes all measures necessary for modifying the attachment to the engine mounting arm.

1	Remove engine cowlings i.a.w. AMM section 71-10.	
2	Disconnect the battery and ECU backup batteries for maintenance i.a.w. AMM section 24-31.	
3	Remove the additional alternator i.a.w. AMM section 61-10.	
4	Check the engine mounting arm for excessive wear on the rear attachment point, if the mounting hole diameter greater than 11 mm, replace the engine mounting arm i.a.w. AMM section 71-00.

<sup>15</sup> Minimum 24 hours after bonding of the alternator bushing do an engine run-up and test the propeller and alternator for correct operation.
