## MANDATORY SERVICE BULLETIN

MSB 40-085/1  
MSB D4-106/1  
MSB F4-036/1  
MSB 40NG-058/1

Type: DA 40, DA 40 D, DA 40 F, DA 40 NG

Removal of the pilot side gust lock mount.

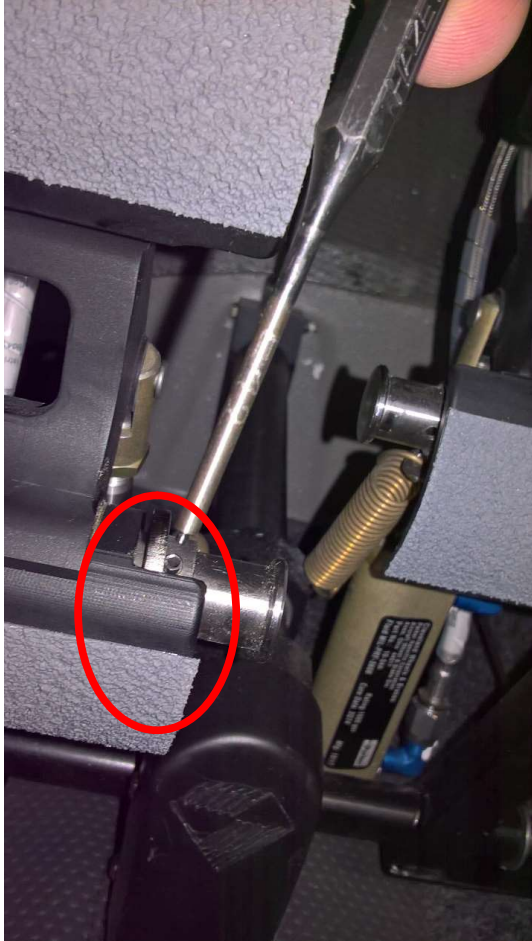
Picture 1

During production check-out and subsequent investigation, on two airplanes it was noticed that with the adjustable rudder pedals in full forward position, the gust lock mounts slightly touch the canopy gas spring damper, which may cause a slight reduction in available rudder travel. The reason on this two particular airplanes was an unfavorable combination of production tolerances and it cannot be excluded that other airplanes of the same build status are also affected. Therefore this Service Bulletin prescribes removing of the gust lock mounts on the pilot side rudder pedals to ensure sufficient clearance regardless of production tolerances and rudder pedal position.

1	Position the pilot electrical or mechanical rudder pedal full rearward.
2	Remove the spring pin from the LH and RH Pilot rudder pedal with a 3mm punch with a centering pin (see picture 1). Make sure that the spring pin does not collide with the washer with hole (see picture 2).
