MANDATORY SERVICE BULLETIN NO. MSB 40NG-063

MLG Support Plate.

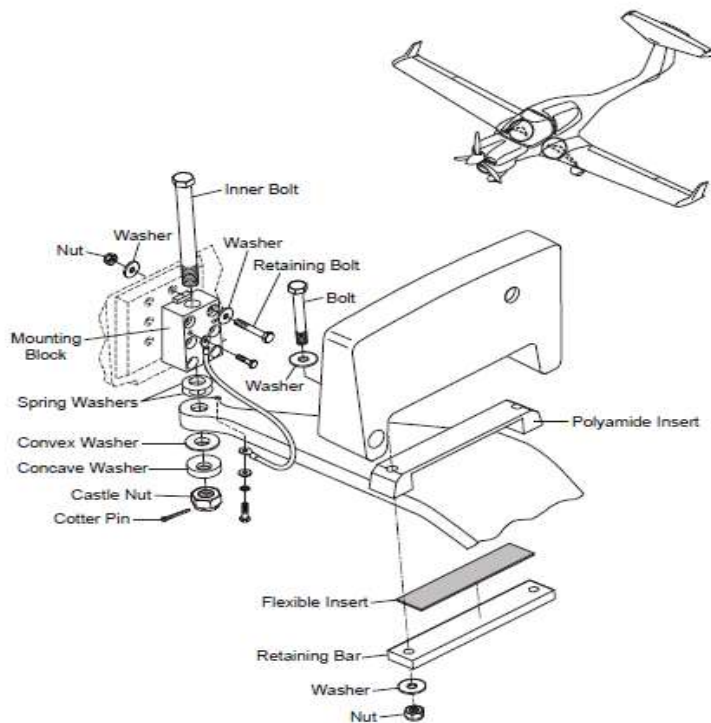
Figure 1 - MLG Strut Mounting

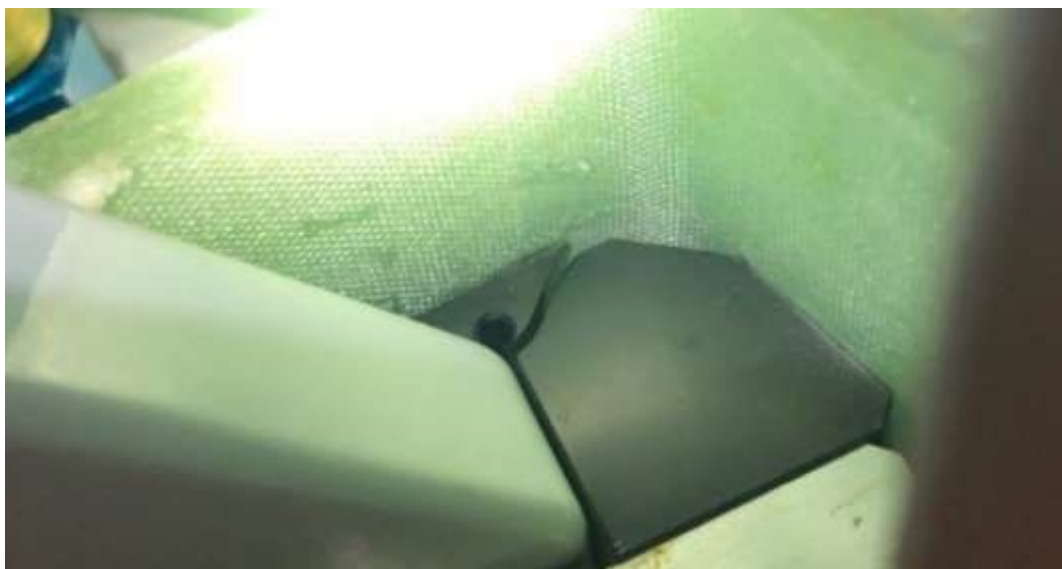
Several MLG Support Plates were found cracked. Diamond is investigating for further occurrences of this.

Figure 2 - Cracked MLG Support Plate (Polyamide Insert)

Step 2: Inspect the MLG Support Plate(polyamide insert) for cracks and replace as necessary. Self-Locking nuts must be replaced on reinstall.
