RECOMMENDED SERVICE BULLETIN NO. RSB 40NG-076 REV. 0

Type: DA 40 NG

Upper cowling air duct modification.

WORK INSTRUCTION WI-RSB 40NG-076 REV. 0

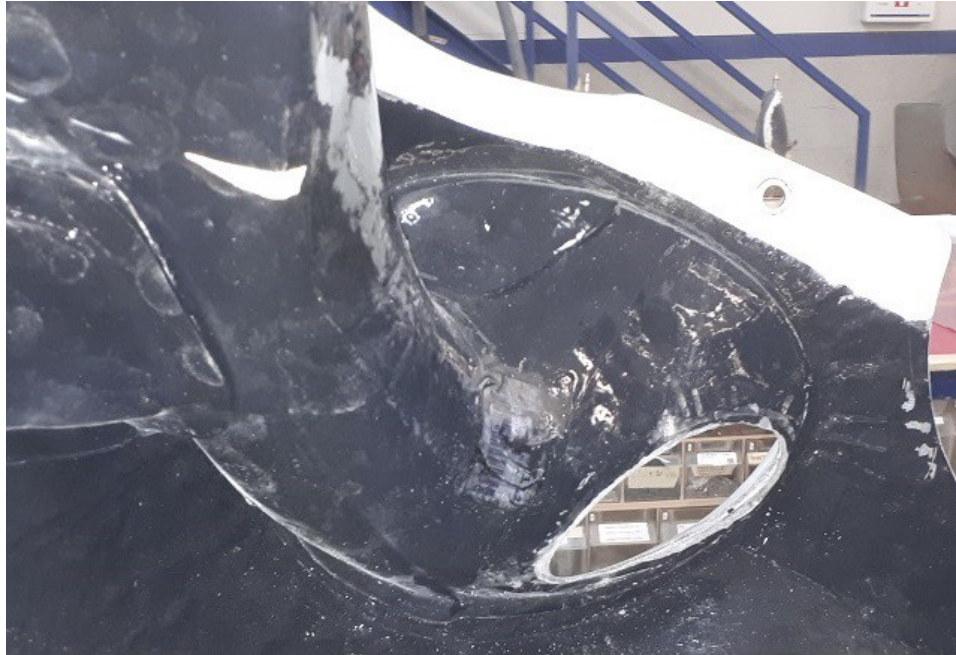
Figure 1. View after removing the secondary air duct, looking forward.

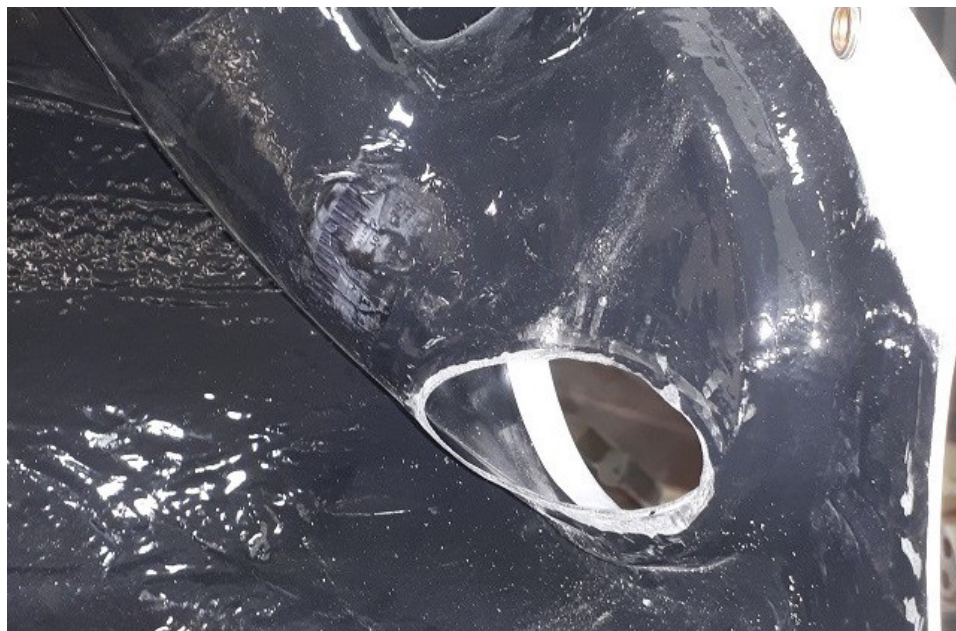
Figure 2. View after removing the secondary air duct, looking towards the top surface of the cowling.

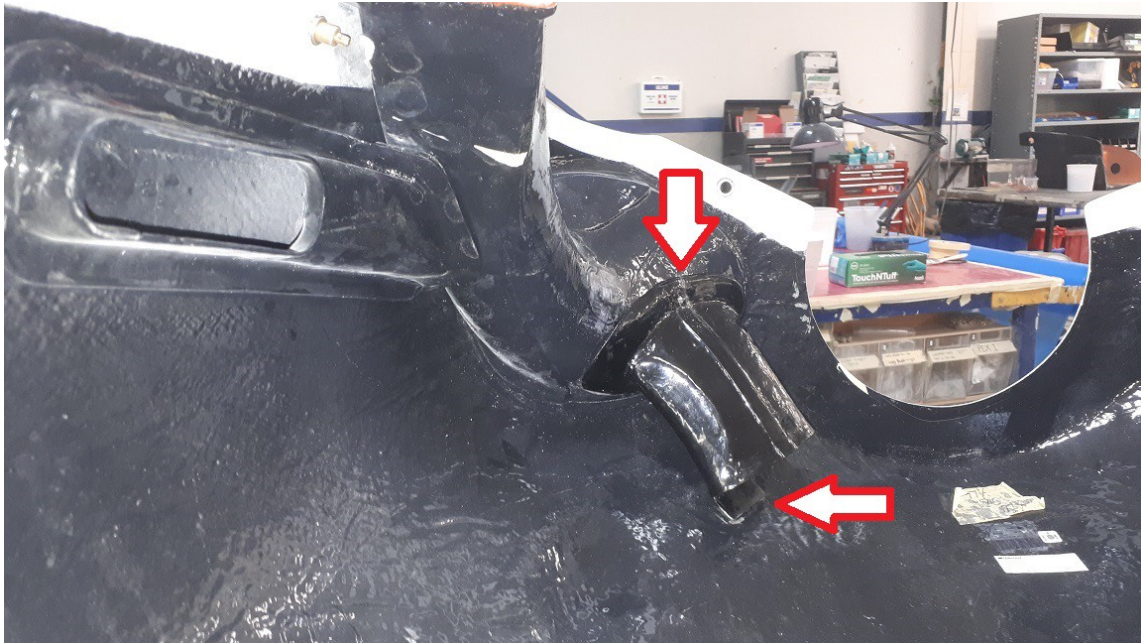
Figure 3. Position of the new secondary air duct. Areas to be bonded shown by arrows.

- III. Prepare bonding paste per AMM Section 51-20.
12. Bond the new secondary air duct (item 2) into position:
 - A. Refer to Figure 3.
 - B. Bond the flange of the new secondary air duct to the existing main duct. Apply bonding paste all around the flange.

- C. Bond the tab of the new secondary air duct to the upper surface of the cowling.
13. Use waxed 2.4 mm diameter Cleco fasteners to hold the duct in position.

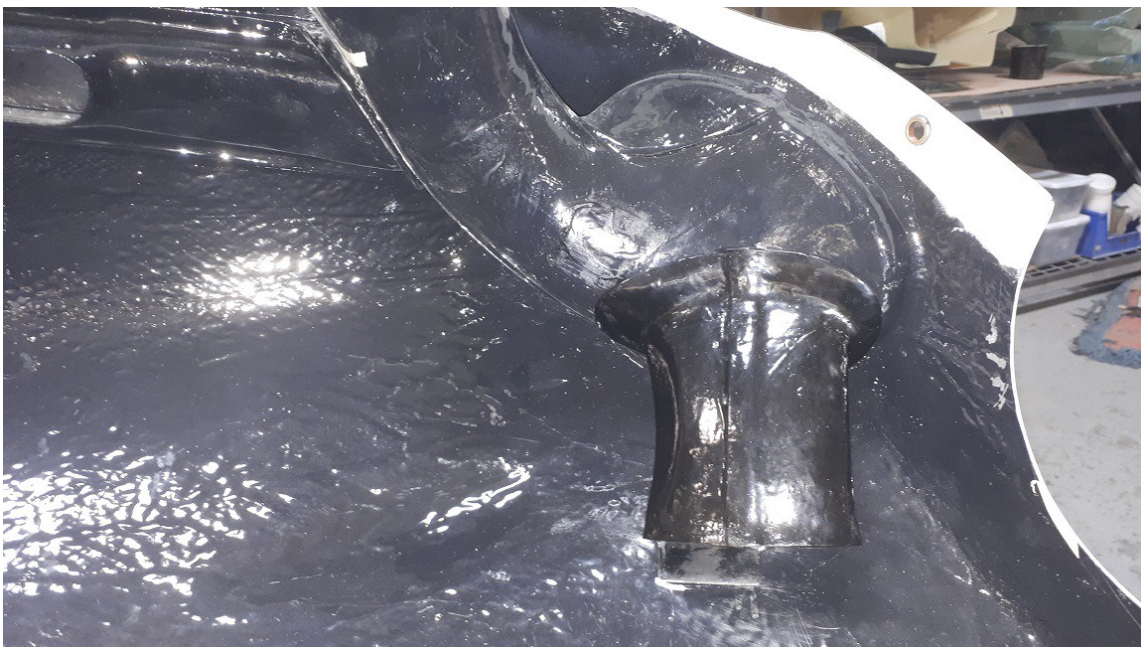
Figure 4. Position of the new secondary air duct (closer view).

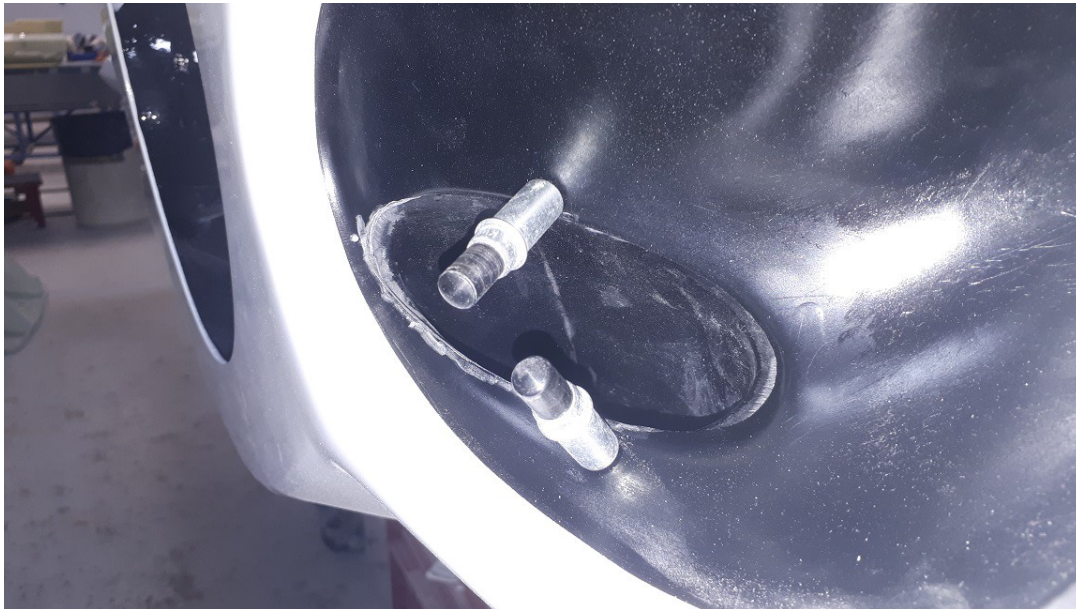
Figure 5. Location of the Cleco fasteners.

1. Ensure the engine is safe.
2. Remove the top cowling. Refer to AMM Section 71-10.
3. Inspect the right-hand air duct on the top cowling for damage.
4. Inspect the sensors near the high pressure pump for damage. Pay special attention to the fuel pressure sensor.
5. Cut and grind out the existing secondary air duct. See Figures 1 & 2.
6. Position the new secondary air duct (item 2), and temporarily secure it with tape. See Figures 3 & 4.
7. Install the cowling on the aircraft, and check the clearance. Adjust the position of the duct if required.
8. Once an appropriate position is determined, mark the position.
9. Drill two 2.5 mm diameter holes through the duct. See Figure 5.
