MANDATORY SERVICE BULLETIN NO. MSB 40NG-077 REV. 0

Model: DA 40 NG

Inspection of gearbox oil.

WORK INSTRUCTION WI-MSB 40NG-077 REV. 0

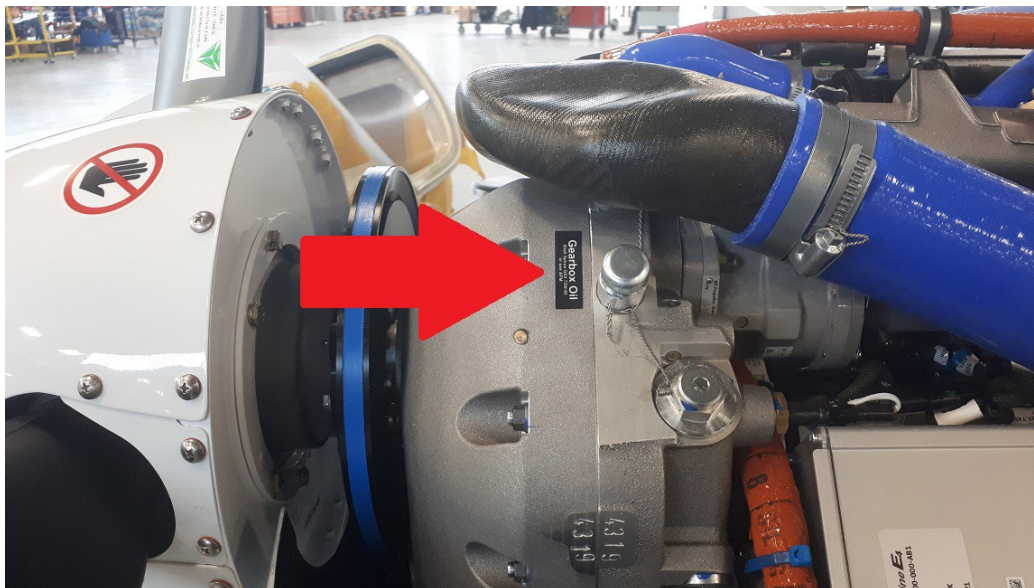
1. Ensure the engine is safe.
2. Remove the engine cowlings. Refer to AMM Section 71-10.
3. Inspect the placard located near the gearbox oil fill plug. Refer to Figure 1.

Figure 1. Location of the placard.

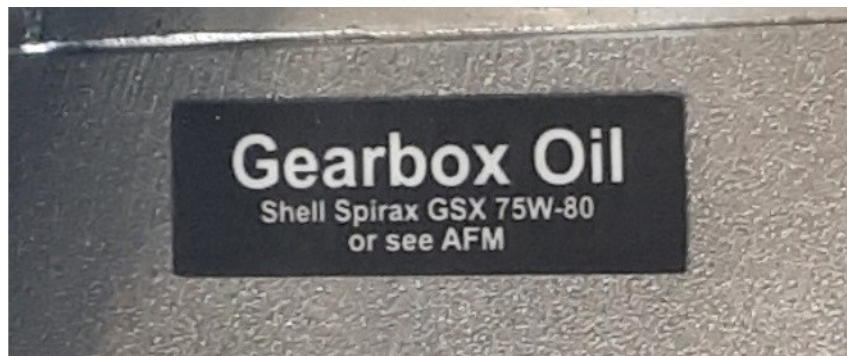
4. If the placard on the gearbox matches the placard in Figure 2, proceed to step 7.

Figure 2. Correct gearbox oil placard.

5. If the placard currently installed on the gearbox does not match the placard shown in Figure 2, replace the placard with placard P/N D64-1126-20-27:

- A. Remove the currently installed placard.
 - B. Thoroughly clean the area where the placard was installed. The surface must be free from contamination.

- C. Apply the new placard. Take care when positioning the placard. Attempting to reposition the placard may damage the placard.
6. Review the aircraft logbooks and determine the gearbox oil used during each service. If the gearbox was serviced with oil not listed in the DA 40 NG AFM Doc. No. 6.01.15-E, or if there is doubt regarding the gearbox oil being used, proceed as follows:
