MANDATORY SERVICE BULLETIN NO. MSB 40NG-078 REV. 1
SUPERSEDES MSB 40NG-078 REV. 0

Inspection of rudder cables in the footwells.

WORK INSTRUCTION WI-MSB 40NG-078 REV. 1
SUPERSEDES WI-MSB 40NG-078 REV. 0

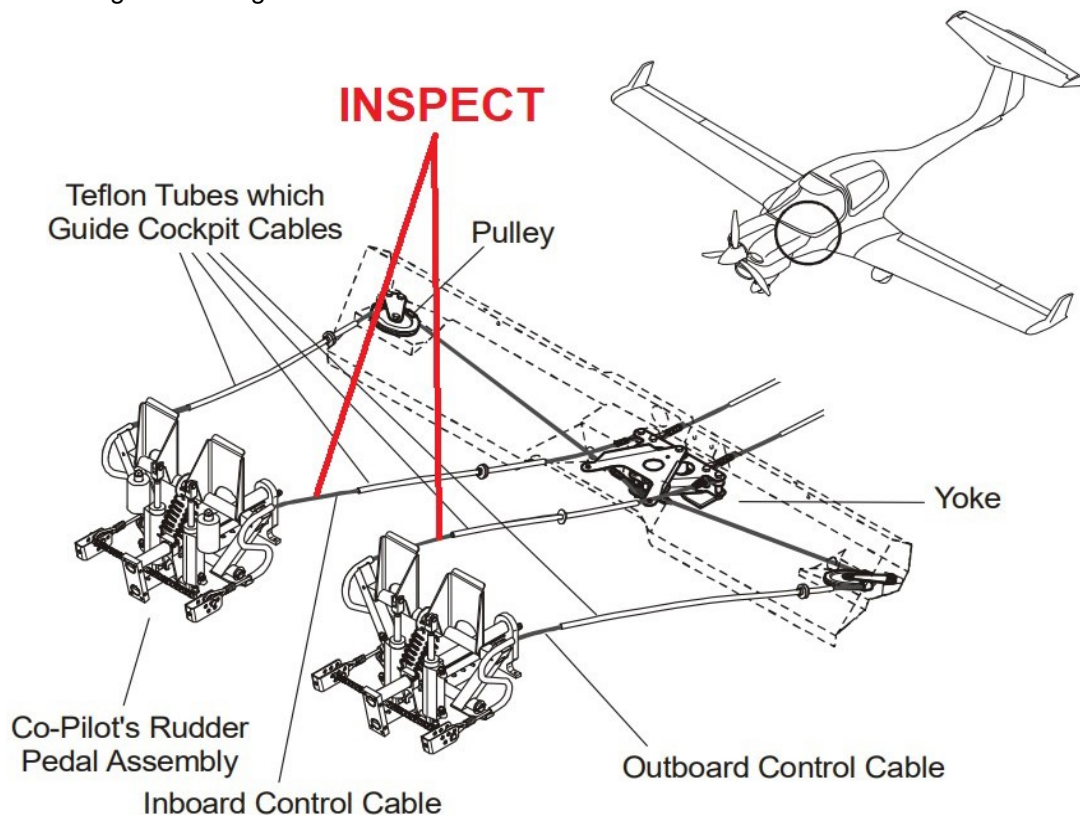
1. Fully depress the right-side rudder pedal.
2. Inspect the inboard rudder cable:
 - A. Use an inspection mirror and flashlight to visually inspect the rudder cable.
 - B. Run a thick cloth along the rudder cable to check for damage. Inspect areas where the cloth snags for damage.

1. Fully depress the left-side rudder pedal.
2. Inspect the inboard rudder cable:
 - A. Use an inspection mirror and flashlight to visually inspect the rudder cable.
 - B. Run a thick cloth along the rudder cable to check for damage. Inspect areas where the cloth snags for damage.

Figure 1. Inspect the inboard cables.

1. If damage was found on the rudder cables, replace the cables in accordance with AMM Section 27-20.
