RECOMMENDED SERVICE BULLETIN NO. RSB 40NG-079 REV. 0

Model: DA 40 NG
S/N: 40.N336 and prior
40.NS001 and 40.NS002
40.NC001 and 40.NC002

Installation of a stiffener on the alternator cable.

WORK INSTRUCTION WI-RSB 40NG-079 REV. 0

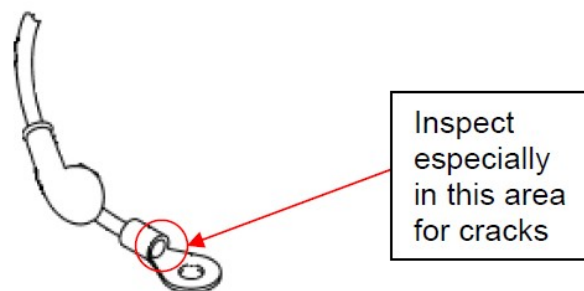
Figure 1. Ring terminal

In some cases cracks on the alternator ring terminal due to high cycle fatigue were observed. This could possibly lead to failure of the cable and continuous discharging of the main battery during flight if not corrected. Diamond has developed a retrofitable stiffener which reinforces the ring terminal to prevent cracks. This Service Bulletin describes the installation of this stiffener.

1. Disconnect the airplane main battery. Refer to AMM Section 24-31.
2. Remove the top and bottom cowlings. Refer to AMM Section 71-10.
3. Disconnect the alternator cable 24007A4 from the alternator.
4. Move the insulating boot from the alternator cable back and inspect the ring terminal for cracks. Refer to Figure 1.
 - If cracks are found, replace the existing alternator cable with a new alternator cable (item 4) and proceed to step 6. Refer to AMM Section 24-30.
 - If there is no crack, proceed to step 5 to install the stiffener (item 1).
