**MANDATORY SERVICE BULLETIN NO. MSB 40NG-080 REV. 2**  
**SUPERSEDES MSB 40NG-080 REV. 1**

Model: DA 40 NG

Inspection of starter wiring connection.

**WORK INSTRUCTION WI-MSB 40NG-080 REV. 2**  
**SUPERSEDES WI-MSB 40NG-080 REV. 1**

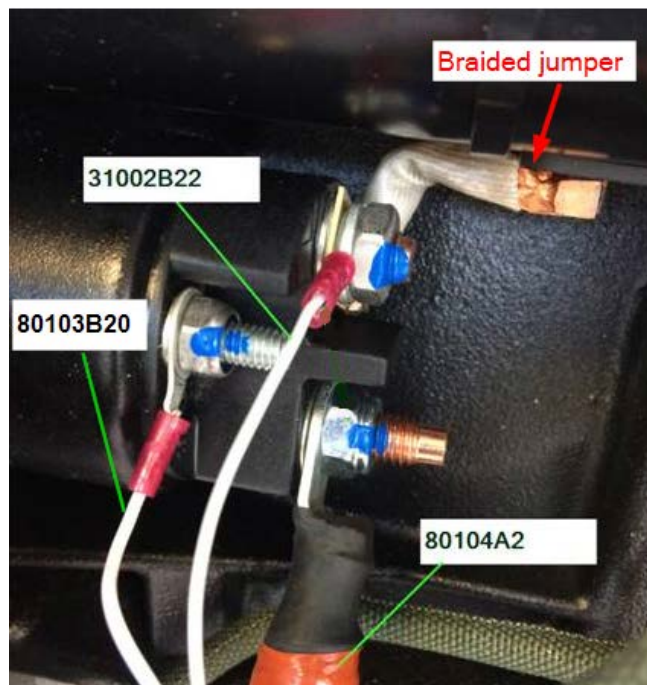
1. Disconnect the main battery for maintenance. Refer to AMM Section 24-31.
2. Remove the top cowling. Refer to AMM Section 71-10.
3. Inspect the starter wiring for correct connection. Refer to Figure 1.
  - The terminal 31002B2 must be connected along with the braided jumper.

Figure 1 - Correct starter wiring connection.

4. If the wire 31002B22 is connected to the same attachment as the braided jumper as shown in Figure 1, that means that the connection is correct and you can proceed to step 8.
5. If the wire 31002B22 is not connected to the same attachment as the braided jumper, the connection is incorrect and you must proceed to the next step.

6. Remove wire 31002B22 from the incorrect location, and reinstall it in the correct location. Refer to Figure 1.
7. Clean the working areas and check for foreign objects.
8. Connect the main battery after maintenance. Refer to AMM Section 24-31.
9. Check all altered, replaced, repaired parts for proper function.
10. Install the top cowling. Refer to AMM Section 71-10.
11. Do an engine ground run-up. Refer to AMM Section 71-00.
12. Make all necessary entries into the logbooks.
13. Submit the execution report to [Techpubs@diamondaircraft.com](mailto:Techpubs@diamondaircraft.com).
