OPTIONAL SERVICE BULLETIN NO. OSB 40NG-082 REV. 0

Model: DA 40 NG

Installation of Alternate Electric Fuel Pump.

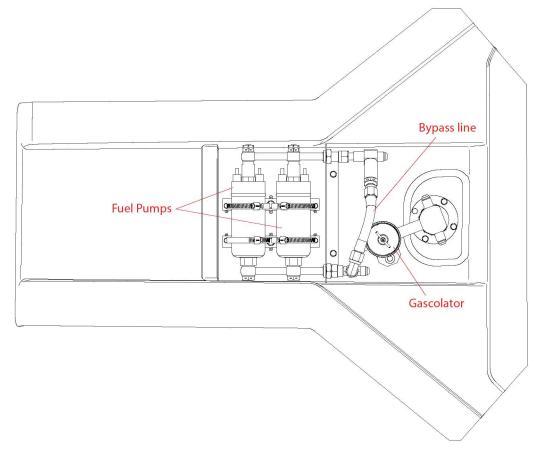
Figure 1. Fuel pumps overview.

- 1. Incorporate AMM-TR-MÄM 40-1119 into the Airplane Maintenance Manual or use an AMM revision in which AMM-TR-MÄM 40-1119 has been incorporated.
- 2. Incorporate AFM-TR-MÄM 40-1119 into the Airplane Flight Manual or use an AFM revision in which AFM-TR-MÄM 40-1119 has been incorporated.
- 3. Remove the existing fuel pump assembly D44-2823-51-00. Refer to AMM Section 28-20.

4. Remove the existing mounting brackets with their screws and washers.

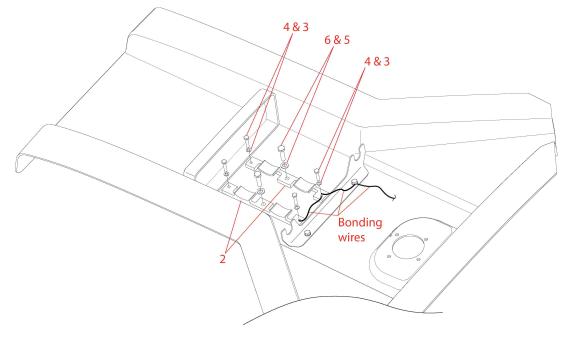
Figure 2. Mounting bracket installation. (shown inverted for clarity)

5. Install the new mounting brackets (item 2) using screws (items 4 and 6) and washers (items 3 and 5). Refer to Figure 2 for installation and orientation of the brackets (item 2).

NOTE: Reuse existing bonding wires if they are serviceable.

6. Install the new fuel pump assembly (item 1). Refer to AMM Section 28-20.

NOTE: Torque the worm drive clamps that hold the fuel pumps to the mounting brackets to 3 - 3.5 Nm (2.2 - 2.6 lbf.ft.).
