# SERVICE INFORMATION NO. SI 40NG-002/1

Austro Engine Mandatory Service Bulletin MSB-E4-009/2  
ATA-Code: 73-20

Mandatory Service Bulletin  
No. MSB-E4-009/2

High Pressure Pump exchange.

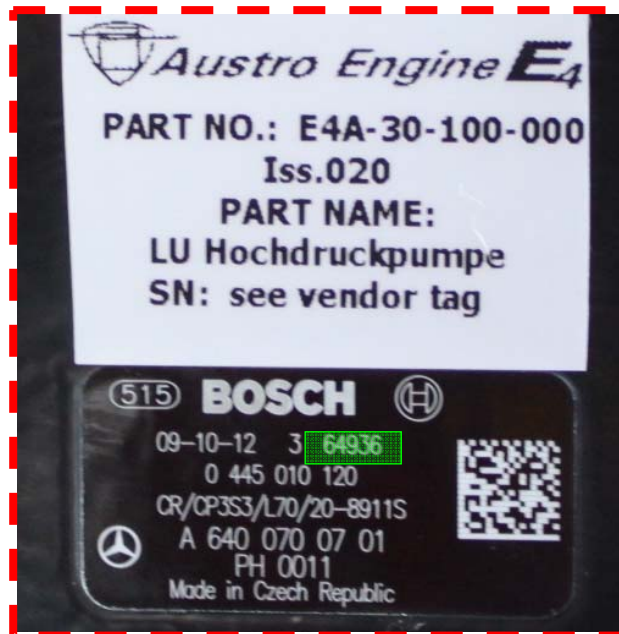
HPP E4A-30-100-000  
 to be **exchanged**

**Replace** the installed HPP according to the E4 Maintenance Manual Doc. E4.08.04, Chapter 73-00-40 using the parts defined under chapter 3.1.

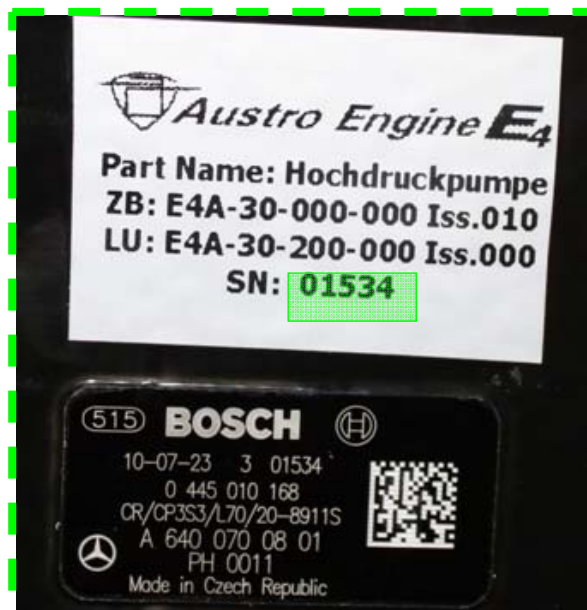
HPP E4A-30-200-000  
 to be **installed**  
 (Iss. of the E4-A-30-000-000  
 could be 010 or 020)
