SERVICE INFORMATION NO. SI 40NG-014

Austro Engine Mandatory Service Bulletin MSB-E4-014/1

MANDATORY SERVICE BULLETIN

Replacement of the Fuel Return Line and Banjo Fitting

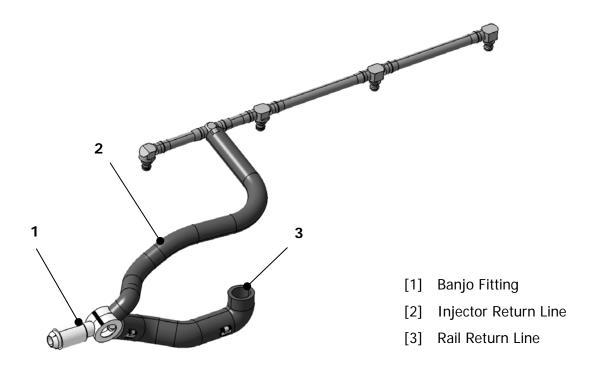
Service experience showed cracks in the fuel return line after about 600 engine operating hours due to inappropriate rooting which could lead to fuel leakage.

- 1. "Removal of the Injector Cover" according to Maintenance Manual E4.08.04, chapter 85-00-11.
- 2. Replacement of the Injector Return Line and Banjo Fitting according the following steps:
