SERVICE INFORMATION NO. SI 40NG-019

Austro Engine Mandatory Service Bulletin No. MSB-E4-007/3

MANDATORY SERVICE BULLETIN

No. MSB-E4-007/3 SUPERSEDES DOC. No. MSB-E4-007/2

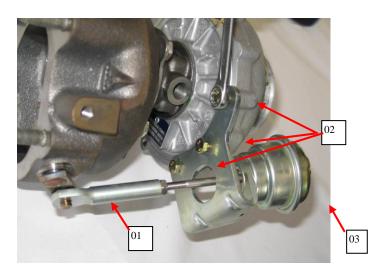
There have been cases where the rod of the Waste Gate Controller cracked. Therefore replacement with latest Waste Gate Controller design is necessary.

- 1. Disconnect Hose at the top of the Waste Gate Controller
- 2. Remove three M6 Bolts [02]
- 3. Remove Circlip [01]
- 4. Disconnect rod from waste gate lever and remove waste gate controller [03]

- 1. Install the three M6 Bolts [02] and torque them with 7 Nm
- 2. Attach external pump to the top of the Waste Gate Controller and apply pressure till the rod starts to move
- 3. Connect rod to waste gate lever
- 4. Adjust Waste Gate Controller according to Engine Maintenance Manual E4.08.04, Chapter 81-00-32.

Note: For fixing of the rod on the waste gate lever use new circlip.
