## SERVICE INFORMATION NO. SI 40NG-027

EASA Airworthiness Directive No. 2013-0025R1 and Austro Engine Mandatory Service Bulletin MSB-E4-007/4

# MANDATORY SERVICE BULLETIN

**No. MSB-E4-007/4**  
**SUPERSEDES DOC. No. MSB-E4-007/3**

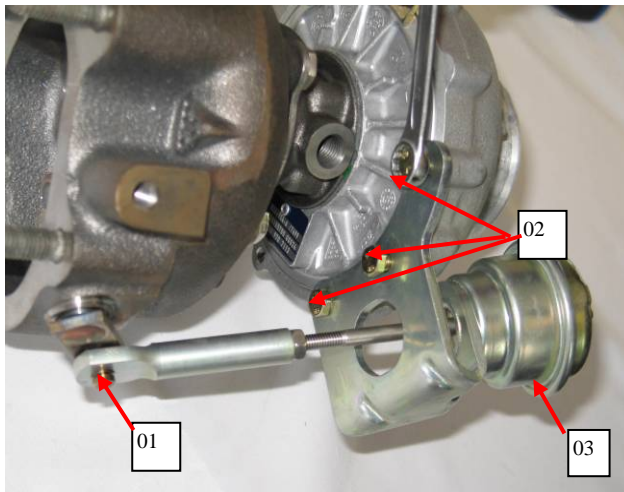
There have been cases where the rod of the Waste Gate Controller cracked. Therefore replacement with latest Waste Gate Controller design is necessary.

1. Disconnect Hose at the top of the Waste Gate Controller
2. Remove three M6 Bolts [02]
3. Remove Circlip [01]
4. Disconnect rod from waste gate lever and remove waste gate controller [03]

1. Install the three M6 Bolts [02] and torque them with 7 Nm
2. Attach external pump to the top of the Waste Gate Controller and apply pressure till the rod starts to move
3. Connect rod to waste gate lever
4. Adjust Waste Gate Controller according to Engine Maintenance Manual E4.08.04, Chapter 81-00-32.
