SERVICE INFORMATION

No. SI 40NG-053

GARMIN Service Advisory No. 1372 Rev. B

SUBJECT: Unavailable RNAV (GPS) approaches due to lack of VDA

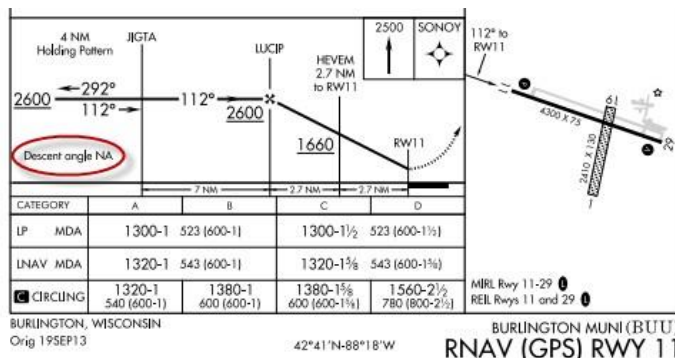
A limited number of RNAV (GPS) approaches, including all service levels, are unavailable for selection when the approach includes LP minima and also has no published vertical descent angle (VDA). See the example in Figure 1.

Figure 1: No Published Vertical Descent Angle (VDA) Example

- G1000, Cirrus Perspective, Embraer Prodigy, G950, and G900X GDU software versions 15.00 and later
- G2000, G3000, and G5000 GDU software versions 5.00 and later
- GNS 400W/500W Series main software versions 5.10 and later
- GTN 6xx/7xx Series main software versions 5.13 and later
