SERVICE INFORMATION

NO. SI 40NG-061

Austro Engine Mandatory Service Bulletin No. MSB-E4-022/1
ATA-Code: 71-00

No. MSB-E4-022/1
SUPERSEDES MSB-E4-022

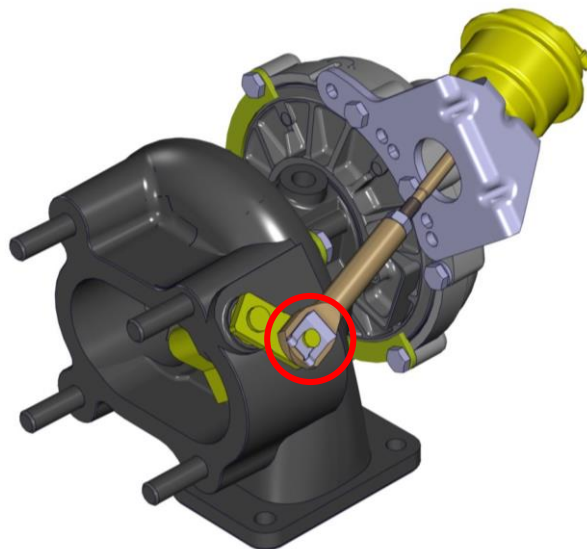
Figure 4: Waste Gate Circlip

A range of waste gate control rods with insufficient fatigue life has been identified. Failure of the waste gate control rod will lead to a partial loss of power. This Service Bulletin describes the identification and replacement of the affected waste gate controllers. In addition an improved circlip is installed.

3. For waste gate controllers with markings as identified under 2. replace the waste gate controller with a waste gate controller not marked as listed under 2. according to Maintenance Manual section 81-00-33.
4. If MSB-E4-024/1 or RSB-E4-024 is not installed, replace the circlip DIN6799-5 with the spring loaded circlip E4A-41-100-801. For removal and installation refer to Maintenance Manual E4.08.04. Refer also to figure 4
