# SERVICE INFORMATION

## NO. SI 40NG-062

# MANDATORY SERVICE BULLETIN

## No. MSB-E4-024/1

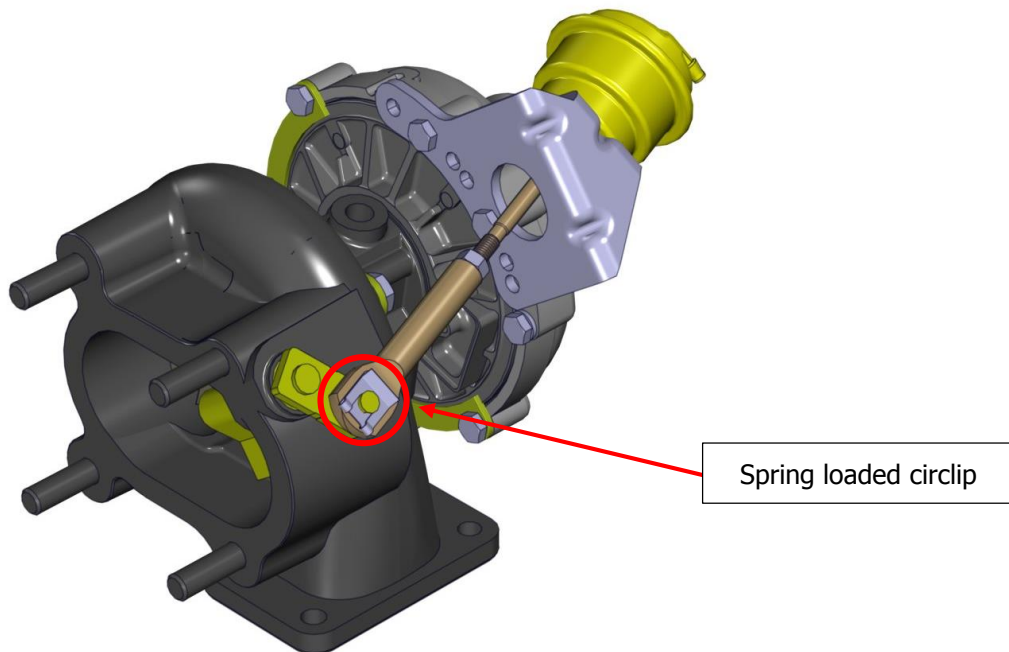
This Service Bulletin describes the replacement of the waste gate circlip, which prevents the waste gate actuator connection rod from disconnecting from the waste gate bolt of the turbo charger. An improved circlip design prevents the incorrect installation of the circlip.

Example: Turbo charger for engine configuration "-A" with new spring loaded circlip

Replace the circlip DIN6799-5 with the spring loaded circlip E4A-41-100-801.
