## SERVICE INFORMATION LETTER NO. SI40NG-066

All DA40NG airplanes

Air Filter

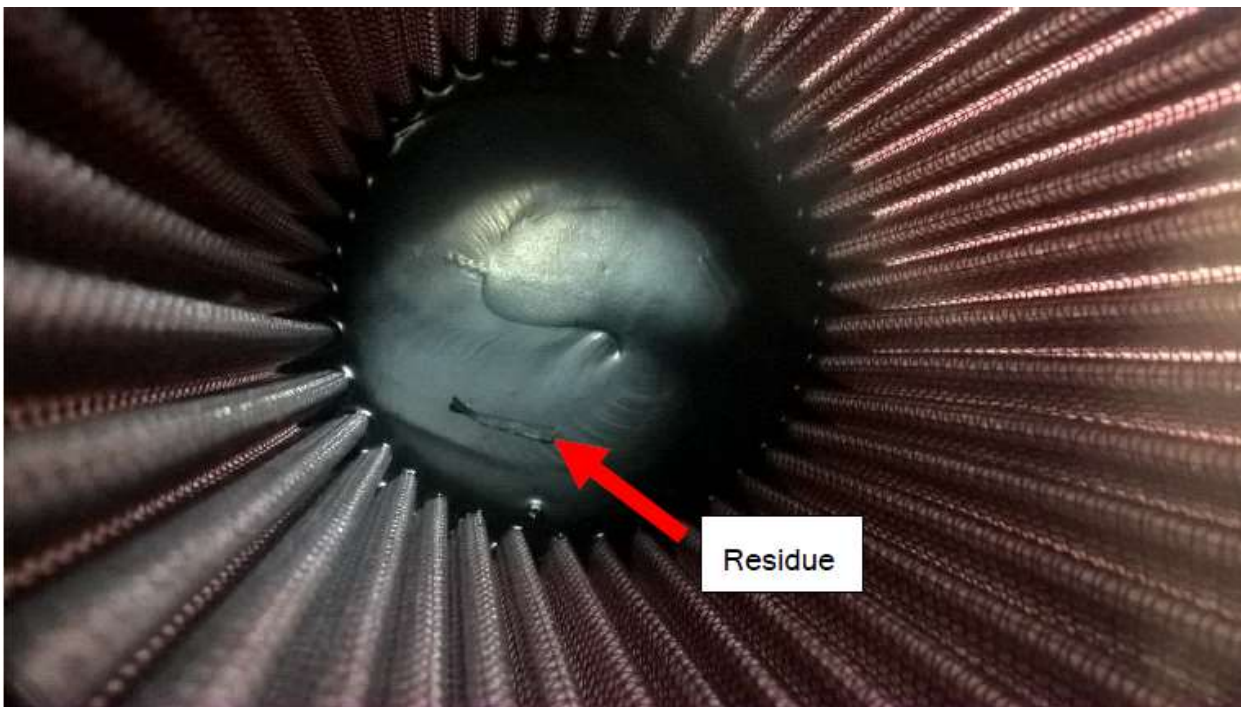
In the aircraft assembly, line residue from manufacturing of the air filter was found in the charged air system.

Diamond Aircraft Industries Inc. advises maintenance personnel to inspect the bag in which new air filters are delivered and inspect also the inside of new air filters for loose residue from manufacturing.

Undetected residue may enter the charged air system and damage the turbocharger.

If loose residue is detected, remove it carefully prior to installation of the air filter.

If there is any doubt that the removal of the residue will affect the filter function or all residue cannot be removed, replace the air filter with a new air filter.
