SERVICE INFORMATION LETTER NO. SI40NG-078

EASA AD 2021-0055-E and Austro Engine Mandatory Service Bulletin MSB-E4-030 - Oil Pump Replacement

MANDATORY SERVICE BULLETIN

Oil pump replacement

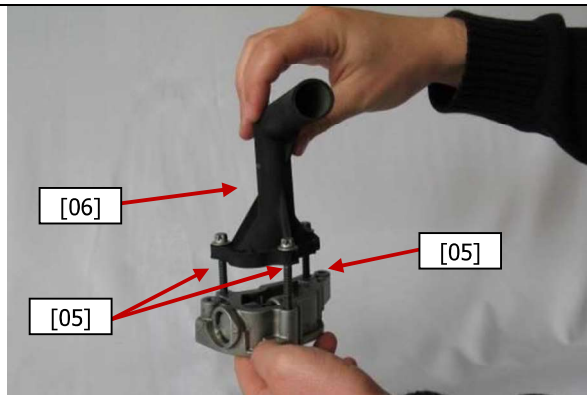
Fig. 11

Removed oil pump (E4A-50-000-BHY)

Loosen three screws [05] of the oil pump and remove the oil suction pipe with the integrated oil strainer [06] (E4A-50-100-BHY) from the old oil pump.

After removal of the oil suction pipe, examine the oil pump gears for damage.

Note: The oil suction pipe with oil strainer and the screws [05] must be reused for the new oil pump installation.

In case of a blocked, and/or partially blocked, and/or damaged oil pump, please contact Austro Engine for further instructions.
