**SERVICE INFORMATION LETTER NO. SI40NG-079**

EASA AD 2021-0055-E and Austro Engine Mandatory Service Bulletin MSB-E4-030/3 - Oil Pump Replacement with updated serial number effectivity.

## No. MSB-E4-030/3 Supersedes MSB-E4-030/2

Oil pump replacement

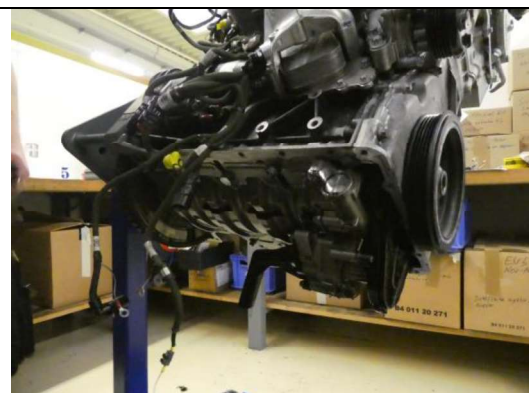
**Fig. 3**

After removal of the oil sump

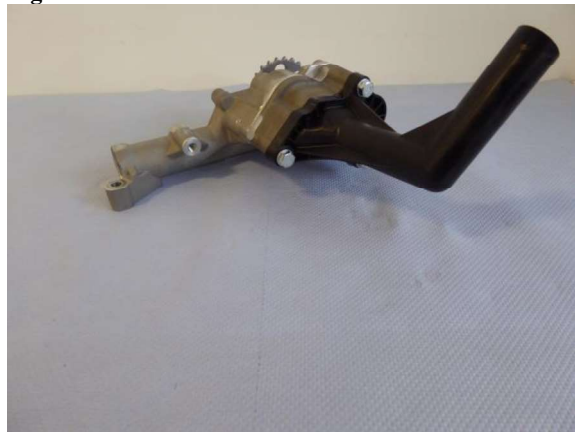
**Fig. 10**

Examine the oil pump for blockage.  
 Make sure that the pump gears move freely when turned by hand.

Loosen the oil pump chain gear from the oil pump chain.  
 Remove the oil pump.

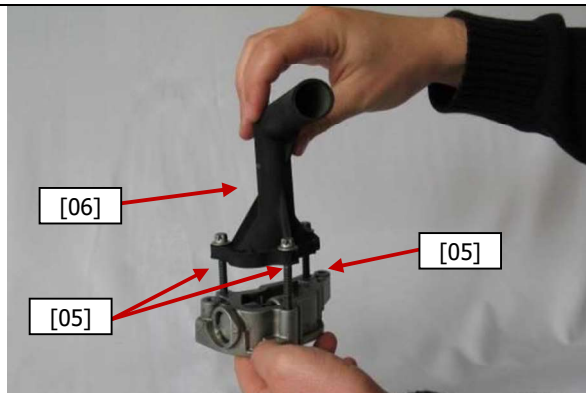
**Fig. 11**

Removed oil pump (E4A-50-000-BHY)

After removal of the oil suction pipe, examine the oil pump gears for damage.

**In case of a blocked, and/or partially blocked, and/or damaged oil pump, please contact Austro Engine for further instructions.**

Loosen three screws [05] of the oil pump and remove the oil suction pipe with the integrated oil strainer [06] (E4A-50-100-BHY) from the old oil pump.

**Note:** The oil suction pipe with oil strainer and the screws [05] must be reused for the new oil pump installation.
