MANDATORY SERVICE BULLETIN

MSB 40NG-016/2

Type: DA 40 NG

Correction of Airspeed Indicator (ASI) markings.

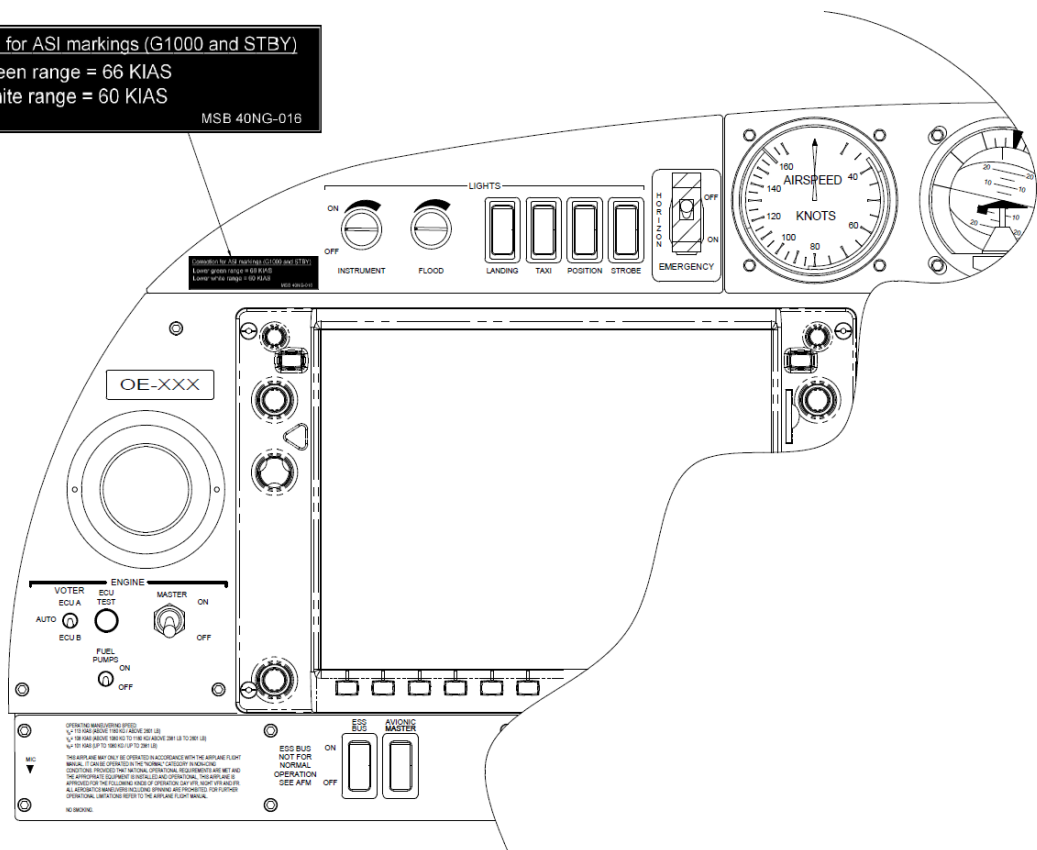
Location:

It has been noticed that the airspeed indicator (ASI) markings of the DA 40 NG have been wrongly applied. The lower ends of the green and white arc are incorrect.

Correction for ASI markings (G1000 and STBY)
 Lower green range = 66 KIAS
 Lower white range = 60 KIAS
 MSB 40NG-016

| 1 | <p>Print page 4 or 5 on self-adhesive paper (or equivalent), cut out placard and install the placard in the cockpit per Appendix 1.</p> <p>Note: This action can be accomplished by the owner/pilot himself and shall be confirmed with reference to this MSB and Action No 1 in an airplane logbook entry.</p> <p>Placard G1000 Configurations:</p> <div style="border: 1px solid black; background-color: black; color: white; padding: 5px; width: fit-content; margin: 10px auto;"> <p>Correction for ASI markings (G1000 and STBY)</p> <p>Lower green range = 66 KIAS</p> <p>Lower white range = 60 KIAS</p> <p style="text-align: right; font-size: small;">MSB 40NG-016</p> </div> <p>Placard Conventional Cockpit Configuration:</p> <div style="border: 1px solid black; background-color: black; color: white; padding: 5px; width: fit-content; margin: 10px auto;"> <p>Correction for ASI markings:</p> <p>Lower green range = 66 KIAS</p> <p>Lower white range = 60 KIAS</p> <p style="text-align: right; font-size: small;">MSB 40NG-016</p> </div> |

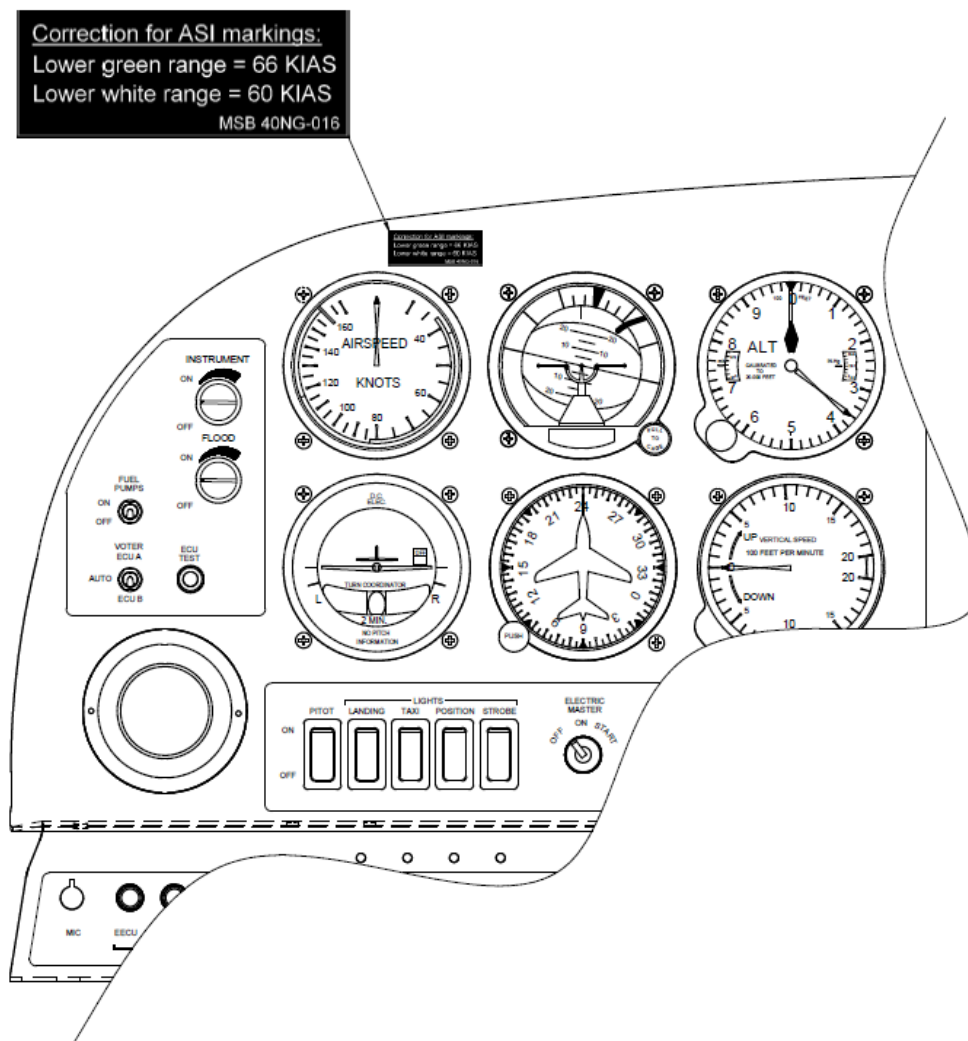
Location:

Correction for ASI markings:
Lower green range = 66 KIAS
Lower white range = 60 KIAS
MSB 40NG-016
