MANDATORY SERVICE BULLETIN NO. MSB 40NG-067 REV. 0

Type: DA 40 NG

Installation of 7 dB attenuators for aircraft equipped with the Garmin G1000 NXi Phase II installation.

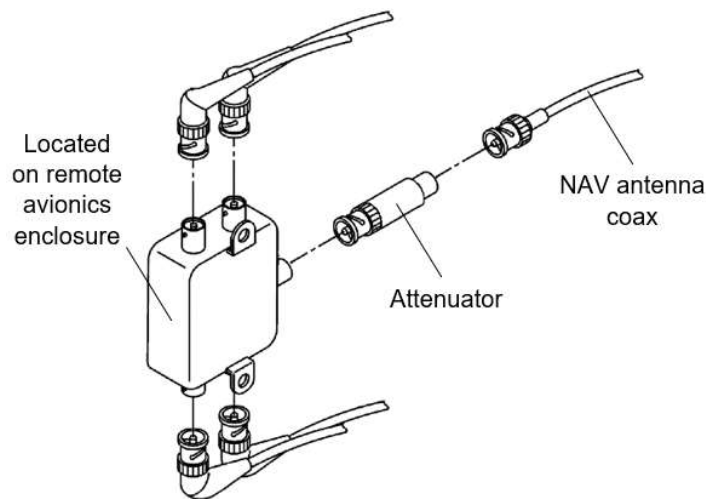
Figure 1. Attenuator installation.

The G1000 NXi Phase II has been approved for installation on DA 40 NG aircraft. It was discovered that the new system was susceptible to electromagnetic interference without the use of 7 dB attenuators. This service bulletin describes installation, of 7 dB attenuators for Phase II equipped aircraft.

1. Remove the baggage compartment. Refer to AMM Section 25-10.
2. Disconnect the main battery. Refer to AMM Section 24-31.
3. Disconnect the ECU backup batteries. Refer to AMM Section 24-31.
4. Remove the HIRF box cover.
5. Install the fixed attenuator (item 1) between the NAV antenna coax and the diplexer (located on the remote avionics enclosure). See Figure 1.
