SERVICE INFORMATION NO. SI 40NG-016

Austro Engine Mandatory Service Bulletin MSB-E4-014/2
ATA-Code: 73-10

MANDATORY SERVICE BULLETIN

Replacement of the Fuel Return Line and Banjo Fitting

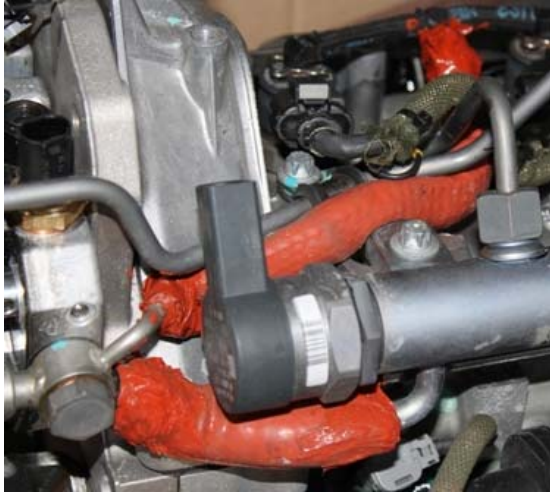
Step 1

Initial situation.

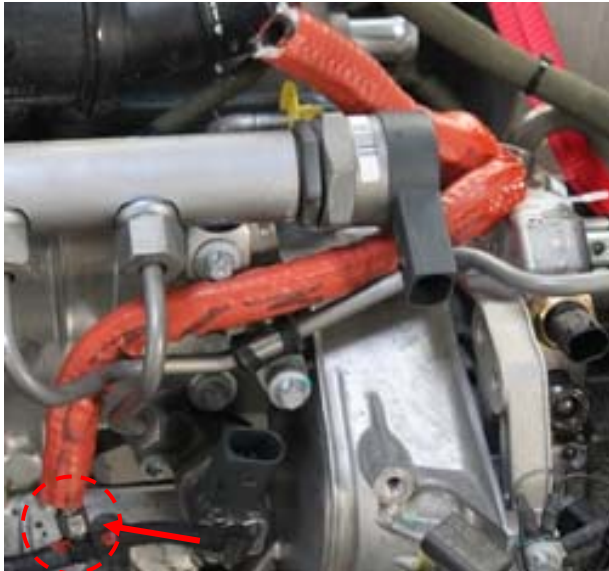
Step 15

Service experience showed cracks in the fuel return line after about 600 engine operating hours due to inappropriate routing which could lead to fuel leakage.

Route the hose as shown and connect the Injector Return Line [5] with new clamp.
