SERVICE INFORMATION NO. SI 40NG-033/1

Austro Engine Mandatory Service Bulletin No. MSB-E4-007/6
ATA-Code: 71-00

MANDATORY SERVICE BULLETIN

Replacement of Waste Gate Controller

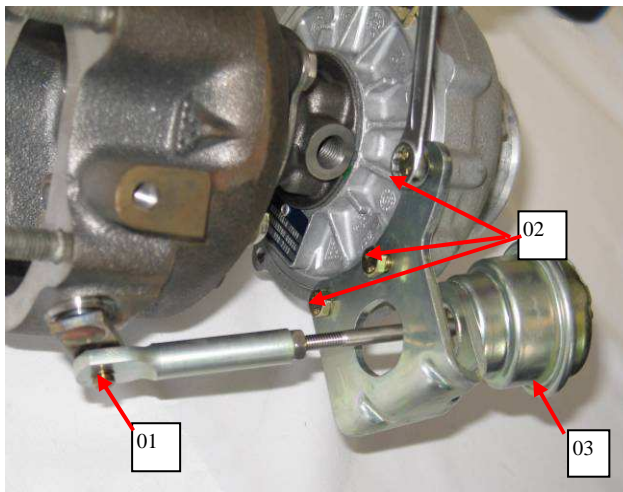
There have been cases where the rod of the Waste Gate Controller cracked. Therefore replacement with latest Waste Gate Controller design is necessary.

Removal of installed Waste Gate Controller:

1. Disconnect Hose at the top of the Waste Gate Controller
2. Remove three M6 Bolts [02]
3. Remove Circlip [01]
4. Disconnect rod from waste gate lever and remove waste gate controller [03]

Install new Waste Gate Controller according to table section 3.1.
