SERVICE INFORMATION LETTER NO. SI40NG-084

Nose landing gear maintenance and inspections.

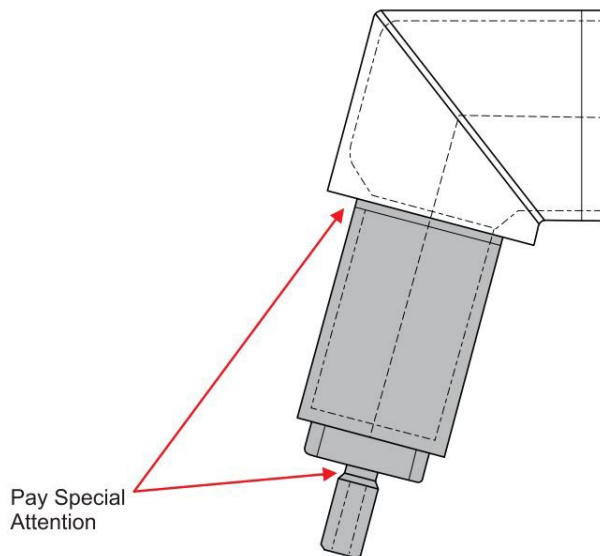
Figure 1. Nose landing gear pivot.

It has been observed that the nose landing gear strut on the DA 40 aircraft may develop cracks at the top of the pivot or at the top of the stud (see the figure below), which may lead to a nose gear collapse, or the loss of the nose wheel and fork. This service information letter highlights the importance of inspecting the nose landing gear, and highlights updates to the aircraft maintenance manual.

1. A single hard landing may severely reduce the life of a nose gear strut.
2. Improper assembly of the nose gear are major contributors to cracking at the stud, which may result in the loss of the fork assembly.

As there are many environmental and operating conditions that may affect the life of the gear, Diamond Aircraft strongly recommends a thorough check of the nose gear pivot and stud every 100 hr in accordance with AMM Section 05-28-50 and Section 32-20-00, which have been updated with more detailed information regarding the disassembly and assembly of the fork assembly. Details have also been added to Section 05-50-00 for greater clarity during hard landing inspections. It is imperative that all suspected hard landings are reported and the airplane inspected.
