MANDATORY SERVICE BULLETIN NO. MSB40-02 Revision 1 (supersedes Revision -)

DA 40 serial numbers 40.005 through 40.022

1.4 Subject:

ATA-Code: 32

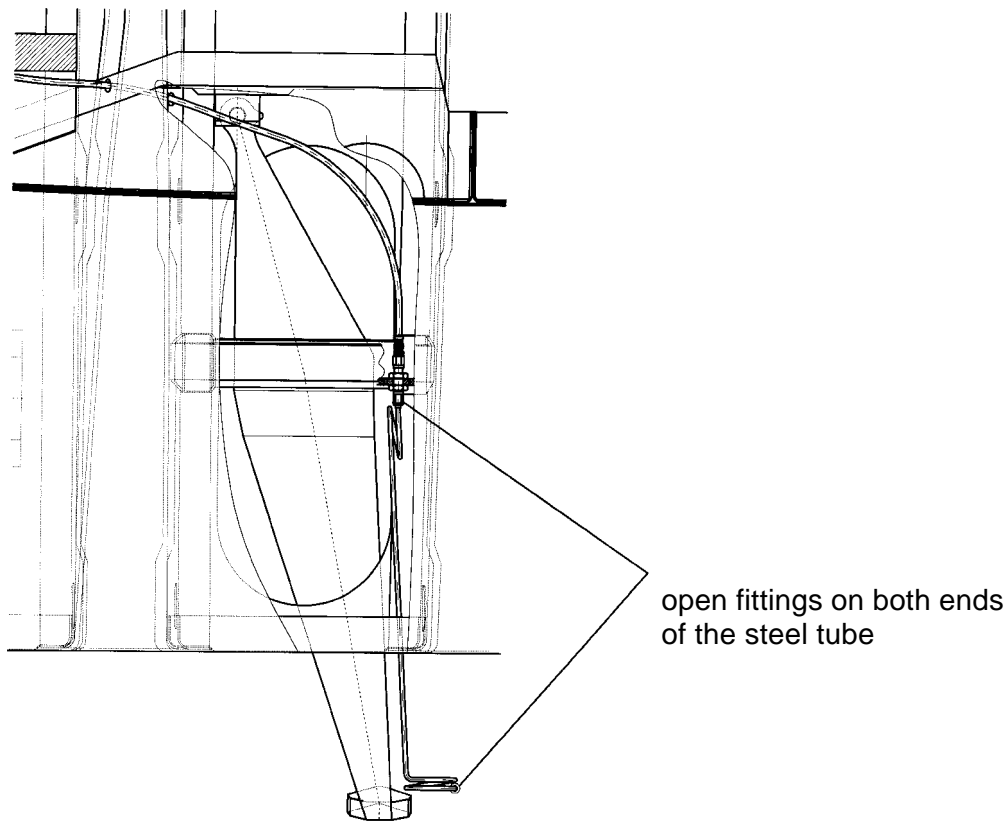
fig. 1

Due to manufacturing problems the quality of the tubing ends of the steel tubes in the wheel brake system is inadequate. To improve the design the steel tubes have been replaced by Teflon hoses. This MSB describes this replacement.

1. empty the brake system according to the AMM
2. remove the steel tube by open the fittings on both ends (see fig. 1)
