MANDATORY SERVICE BULLETIN

NO. MSB 40-030/3

Inspection of the universal joints between fuel selector handle and fuel selector valve.

ATA-Code: 28-23, Fuel System

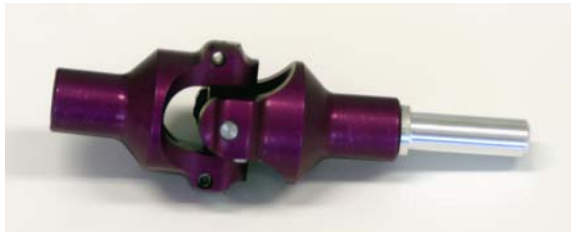
Picture 1: New Joint D41-2823-20-00 rev. "a" or later

B (replace complete universal joint kit with new kit including fuel shaft D41-2823-20-00 rev. a or later):
