# MANDATORY SERVICE BULLETIN

## NO. MSB-40-048/2

### **I.5 Subject**

### INSPECTION FOR POSSIBLE CONTAMINATION OF ENGINE FUEL SYSTEM

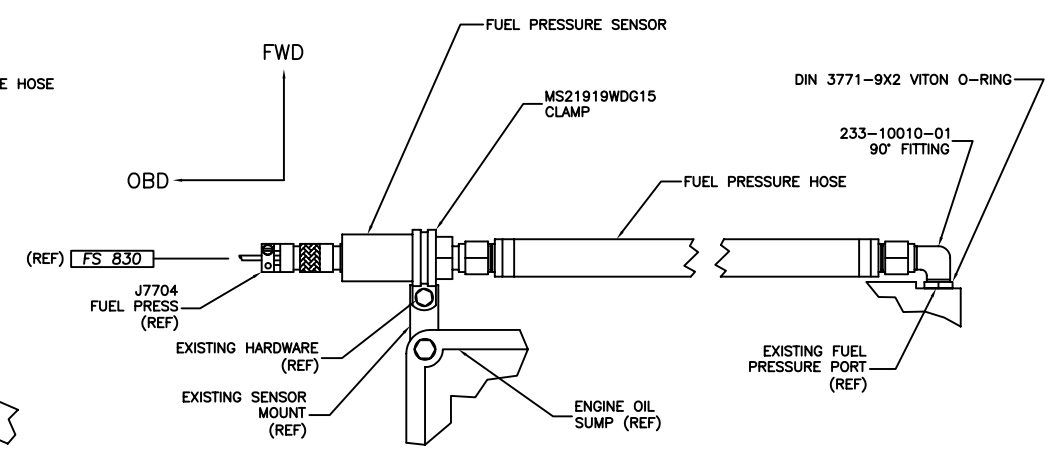
FUEL PRESSURE SENSOR  
(VIEW LOOKING UP)

The suspect fitting is the 90 degree fuel pressure restricted port fitting. The shavings may be on the inside or outside of the parts.

1	Install flow divider.
2	Connect stainless steel fuel lines, inlet fuel hose and vent hose to flow divider.
3	Reinstall 90° inlet fitting p/n D41-7306-00-31 with new O-Ring (P/N 951789) in servo.
4	Install new reduced flow 90° fitting p/n 233-10010-01 with new O-Ring (P/N MS29512-04) in servo.
5	Install fuel injection servo (refer to AMM Section 73-00).
