MANDATORY SERVICE BULLETIN

NO. MSB-40-054/1

NO. MSB-F4-013

“Protection of Pitot, Static and Stall Warning Lines”

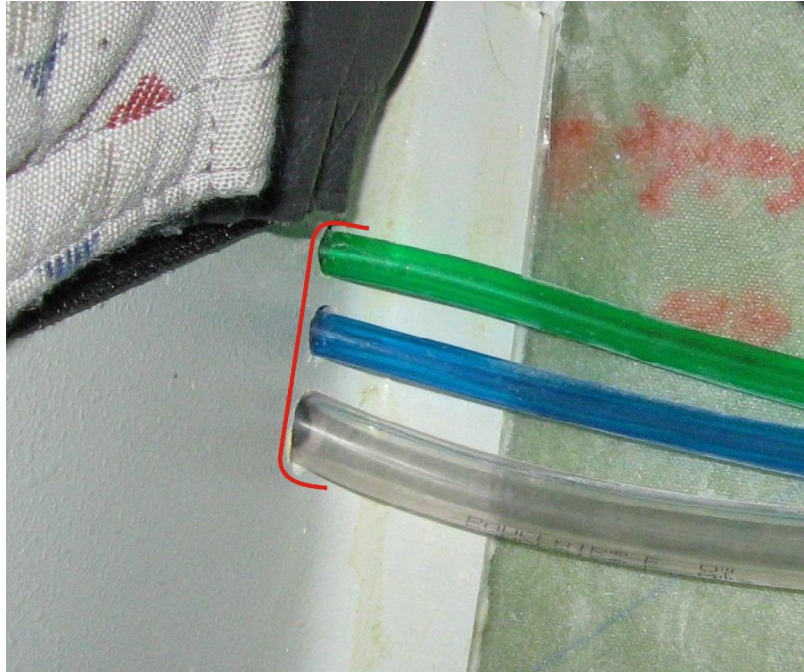
If you find an installation as it is shown on the photograph below, then elongate the three holes so that they become a long one as it is described in step 9.

NOTE: When finding an installation with three single holes through the aft wall of the floor panel the given maximum length of 43 mm may be increased up to a maximum length of 60 mm.
