MANDATORY SERVICE BULLETIN

NO. MSB-40-058

No. MSB-F4-014

“ENGINE HARNESS RESISTOR BOARD”

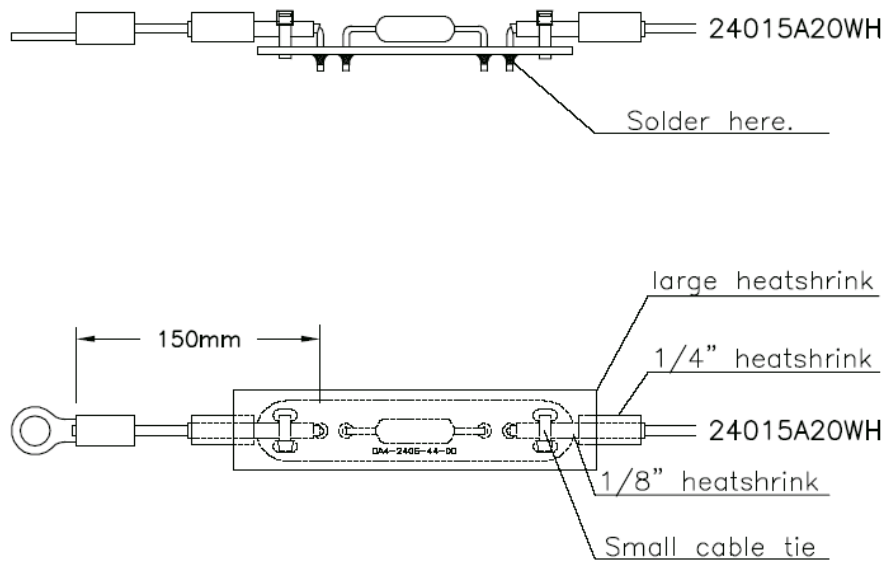
Figure 1

There have been cases where resistors broke over time. With this service bulletin, a pc-board, reinforcing the resistor connections, gets introduced to eliminate breaking.

Large heatshrink not shown in this view:

1	Remove Cowlings. Refer to AMM Section 71-00.
2	Disconnect wire 24015A20 with resistor from AUX terminal on alternator. Refer to AMM Section 92-00.
3	Cut off the resistor from the wire.
4	Prepare wire for soldering: <ul style="list-style-type: none">• Remove outer jacket and shield• Strip wire and tin
5	Apply small piece of 1/8" heatshrink and 1/4" heatshrink over wire 24015A20 prior to soldering. (heatshrink supplied with DA4-2406-44-00SB). Refer also to Figure 1.
6	Solder wire to pad on circuit board. Refer also to Figure 1.
7	Shrink small 1/8" piece heatshrink up as close to solder joint as possible. Refer also to Figure 1.
8	Add small cable tie through board and around heatshrink. (As done on other side of resistor board). (cable tie supplied with DA4-2406-44-00SB). Refer also to Figure 1.
9	Shrink 1/4" heatshrink as close to cable tie as possible. Refer also to Figure 1.
10	Add large heatshrink and shrink it evenly over the whole assembly. (heatshrink supplied with DA4-2406-44-00SB). Refer also to Figure 1.
