MANDATORY SERVICE BULLETIN

NO. MSB-40-060/1

NO. MSB-F4-016/1

„Wing Skin to Spar Bond“

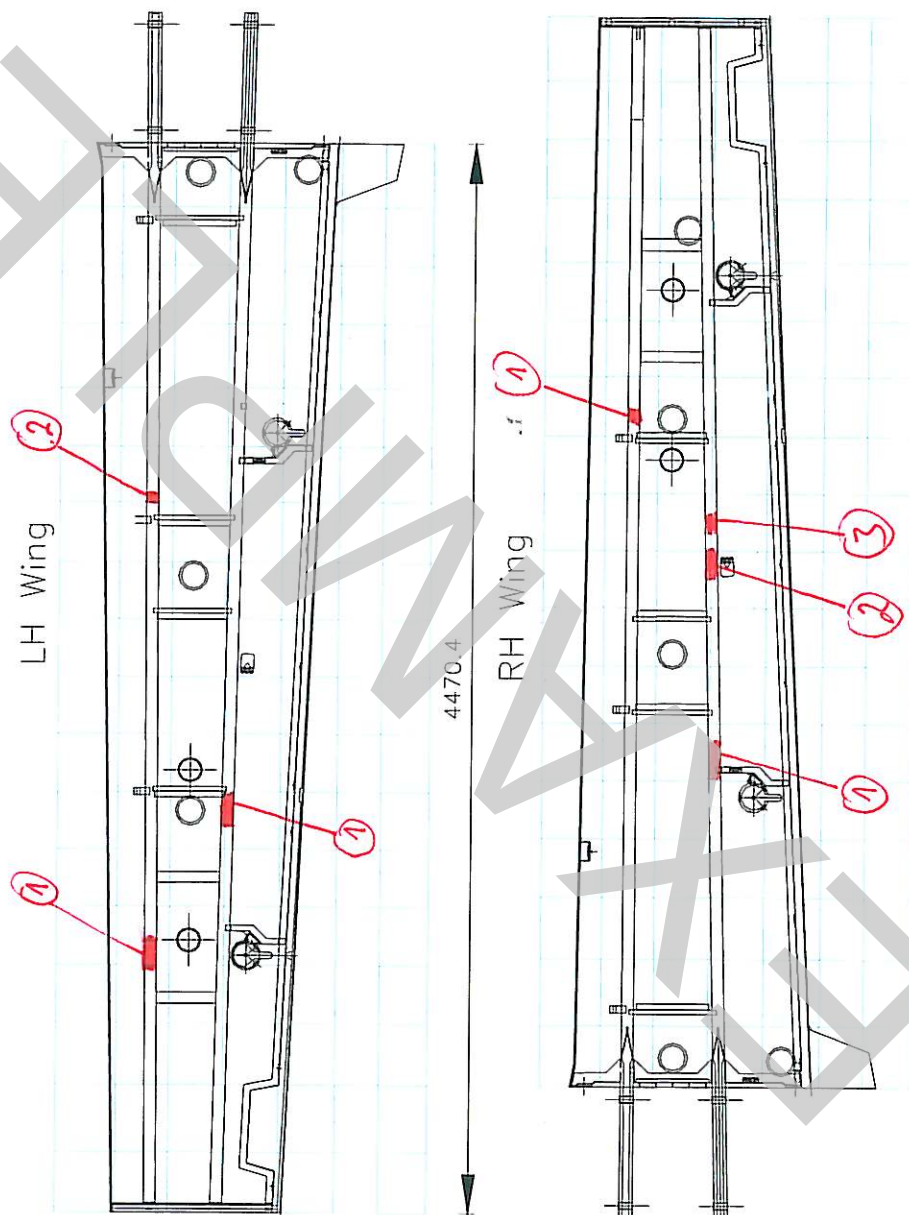
Void Map, Airplane S/N: 40.919

LH FWD Spar				RH FWD Spar			
Item	Length	Wide	Start-Position	Item	Length	Wide	Start-Position
1	102 mm	64 mm	3708 mm	1	51 mm	25 mm	2845 mm
2	51 mm	25 mm	1473 mm	2			
3				3			
4				4			
5				5			
6				6			
Sum	153 mm	free of void length from root rib	1473 mm	Sum	51 mm	free of void length from root rib	2845 mm

LH AFT Spar				RH AFT Spar			
Item	Length	Wide	Start-Position	Item	Length	Wide	Start-Position
1	102 mm	51 mm	2781 mm	1	152 mm	51 mm	1283 mm
2				2	127 mm	51 mm	2159 mm
3				3	76 mm	51 mm	2362 mm
4				4			
5				5			
6				6			
Sum	102 mm	free of void length from root rib	2781 mm	Sum	355 mm	free of void length from root rib	1283 mm

LH Wing			RH Wing		
	Length	Criteria	Yes	No	Length	Criteria
FWD Spar over all void length	153 mm	< 2500 mm (98 inches)	X		51 mm	< 2500 mm (98 inches)
AFT Spar over all void length	102 mm	< 2500 mm (98 inches)	X		355 mm	< 2500 mm (98 inches)
Both Spars over all void length	255 mm	< 3050 mm (120 inches)	X		406 mm	< 3050 mm (120 inches)
Free of void length FWD Spar	1473 mm	greater value > 1070 mm (42 inches)	X		2845 mm	greater value > 1070 mm (42 inches)
Free of void length AFT Spar	2781 mm				1283 mm	
	Passed (further operation permitted)		X		Passed (further operation permitted)
