MANDATORY SERVICE BULLETIN

MSB 40-067

Check of emergency exit lever.

Check of emergency exit lever

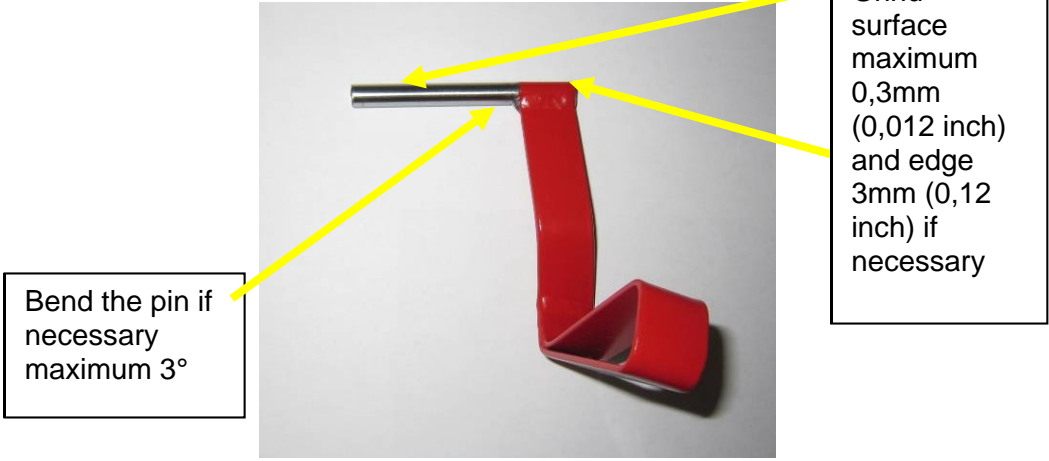
During maintenance action on some airplanes it was found that the emergency exit lever was sitting so tight that smooth operation of the door release was not guaranteed. In order to ensure an instant and smooth door release on every aircraft possibly affected a check of emergency release and corrective actions if required are prescribed on these aircraft.

5	<p>Rework lever pin, refer to picture.</p>

<p>Bend the pin if necessary maximum 3°</p> <p>Grind surface maximum 0,3mm (0,012 inch) and edge 3mm (0,12 inch) if necessary</p> <p>The minimum pin diameter is 5,7mm (0.225 in).</p>
6	<p>Install the modified emergency lever and test the release with hand force. If a release is possible, install the emergency exit lever.</p>
7	<p>If a release is not possible, replace the emergency exit lever with DA4-5200-71-00_1.</p>
8	<p>Seal reading light and emergency lever with Terostat IX.</p>
