MANDATORY SERVICE BULLETIN MSB 40-074 MSB D4-094 MSB F4-028

Reinforcement of aft main spar.

WORK INSTRUCTION
WI-MSB 40-074
WI-MSB D4-094
WI-MSB F4-028

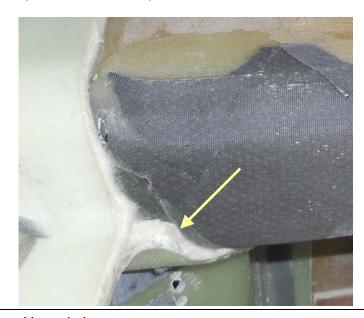
By further testing and investigation it was discovered that the fatigue strength of the aft main spar in the cabin area does not ensure unlimited lifetime. This Service Bulletin prescribes the reinforcement of the aft main spar to correct this condition. As an additional benefit the reinforcement is the basis for the Major Structural Inspection interval increase to 6000 hrs since new and every 4000 hrs thereafter.

Where the reinforcement patches overlap parts other than the aft main spar, trim the reinforcement patch (max cut off 60 mm).
