MANDATORY SERVICE BULLETIN

MSB 40-085/1 MSB D4-106/1 MSB F4-036/1 MSB 40NG-058/1

Type: DA 40, DA 40 D, DA 40 F, DA 40 NG

Removal of the pilot side gust lock mount.

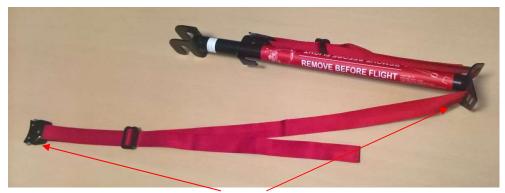
70cm (27.56in) Band length

- Picture 2
- Remove the gust lock mounts from the rudder pedals. 3
- 4 Install the new spring pins into the LH and RH Pilot rudder pedal.
- 5 Prepare the gust lock belt in accordance with picture 3 for use on the Co-Pilot rudder pedals.
