Model DA 40

## RECOMMENDED SERVICE BULLETIN NO. RSB 40-094 REV. 1 SUPERSEDES RSB 40-094 REV. 0

Installation of insulation around the fuel supply line from the engine driven pump to the fuel servo.

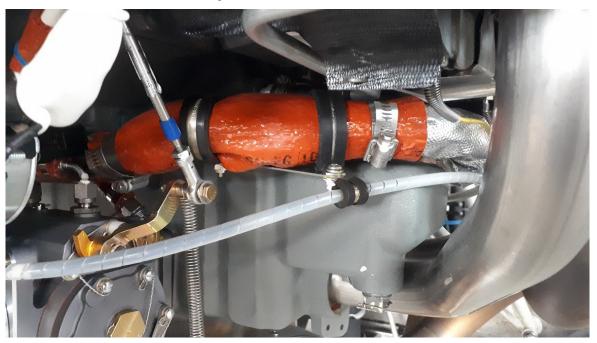
Figure 3. Installation, front view. Note that item 4 has not yet been installed.

- 10. Secure the reflective sleeve with a fire resistant cable tie (item 4).
- 11. Connect the fuel supply line to the engine driven pump.
- 12. Connect the airplane battery. Refer to AMM Section 24-31.
