**MANDATORY SERVICE BULLETIN NO. MSB 40-096 REV. 0**

Model: DA 40-180

Installation of a limitation placard for the GFC 700 autopilot.

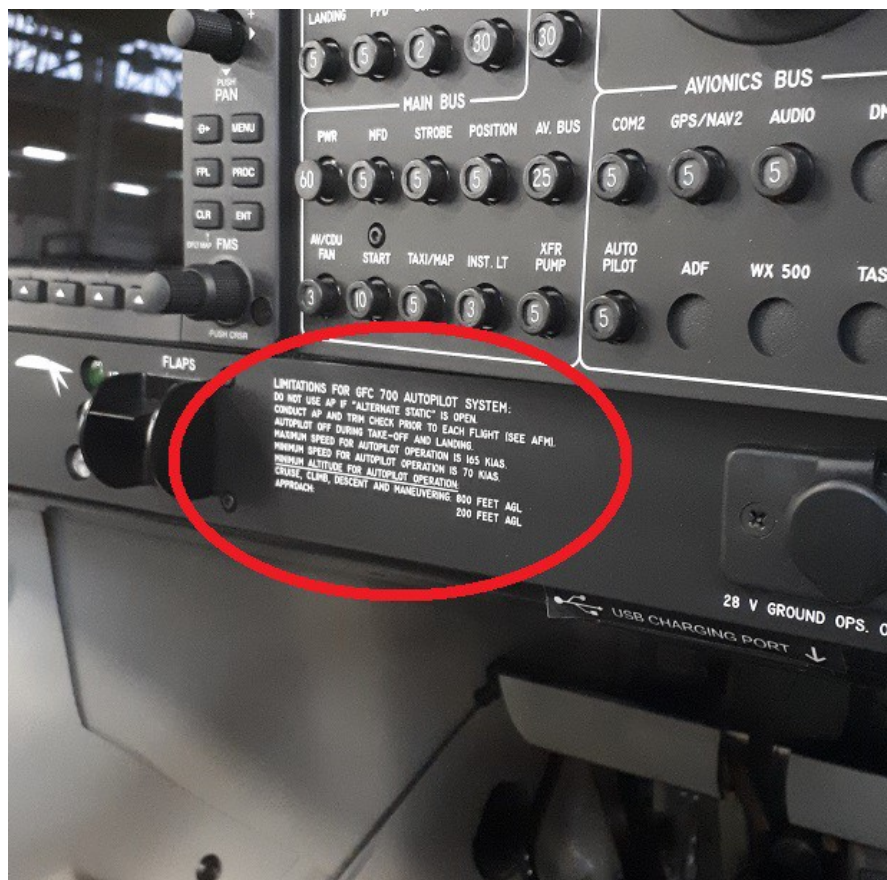
Figure 2. Location of the GFC 700 autopilot limitation placard.

It has come to Diamond's attention that some DA 40-180 aircraft have been delivered without an instrument panel placard specifying the limitations of the GFC 700 autopilot. This service bulletin describes the installation of a limitation placard for aircraft where the placard is missing.

2. If there is no placard specifying the limitations of the GFC 700 autopilot, install item 1 under the circuit breakers as shown in Figure 2. Clean the area with isopropyl alcohol prior to installing the placard. The area must be free of contamination. Take care when positioning the placard. Attempting to reposition the placard may damage it.
