## MANDATORY SERVICE BULLETIN NO.

### MSB 40-103 / MSB F4-042 / MSB D4-114 / MSB 40NG-084

Actions to prevent Passenger Door Separation: Installation of Placards, AFM Procedure update and Inspection/Data Gathering.

Diamond Aircraft Industries have received reports of passenger door separating from aircraft during flight. In some cases, operators forgot to latch the passenger door before flight and that there have been attempts to latch the door during flight, which led to separation of the passenger door.

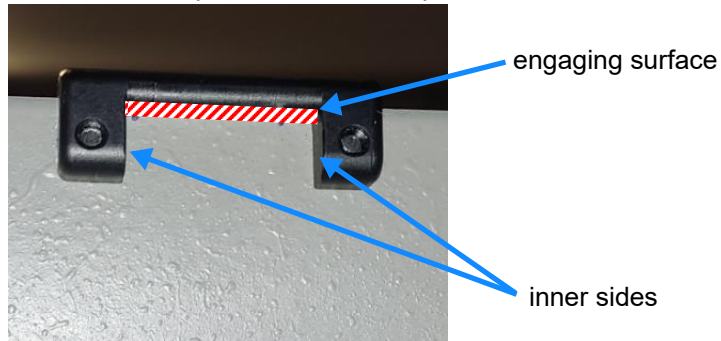
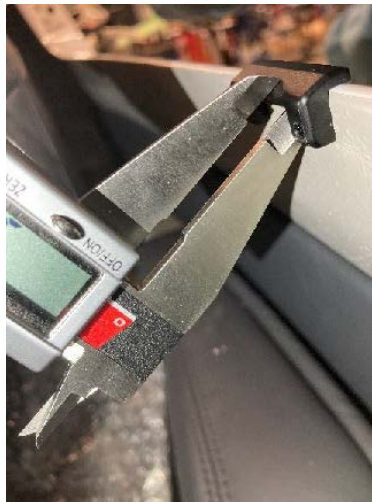
- The thickness of the retaining block measured perpendicular to the upper surface must be greater than:
  - 4 mm for retaining block DA4-5200-00-69\_02 (extended with undercut) or
  - 6 mm for all other retaining blocks. Refer to step 7 for retaining block versions.

- The width of the retaining block must be greater than 10 mm. Refer to Figure 3.
- The variation in thickness of the measured along the width of the retaining block must be less than 0.2 mm.

If the retaining block does not meet one or more of the acceptable conditions mentioned in step 9, take notes and replace the retaining block after the WI is completed. Refer to section IV for removal/installation of the retaining block.

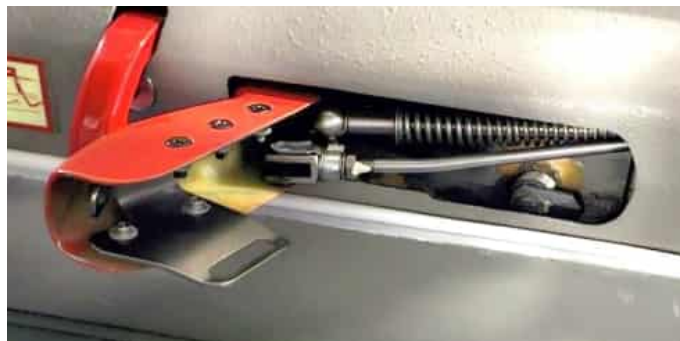
15. If the old passenger door latch is installed (refer to step 14), visually inspect the spring:  
Refer to Figure 10.
- Move the passenger door handle to the unlatched position.
  - Visually inspect the spring.
    - Look specifically for a broken winding, replace the spring if found broken.
  - Record any findings on the execution report in Appendix A.

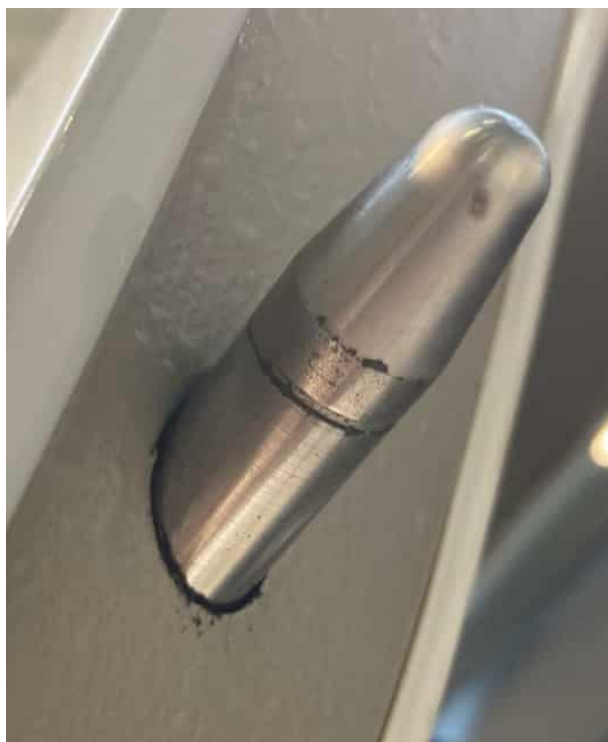
21. Examine the latching bolts of the passenger door for looseness, excessive play, wear, corrosion and poor condition. Refer to Figure 14.
- It must not be possible to rotate the latching bolts by hand force.

- No signs of corrosion is allowed.
    - If you find signs of corrosion on the latching bolts, take note and replace the latching bolts after the WI is completed. Refer to AMM 52-10 for replacement.

- No deformation (dents, bends, cracks) on the latching bolts is allowed.
    - If deformations of the latching bolts are found, take note and replace the latching bolts after the WI is completed. Refer to AMM 52-10 for replacement

Figure 14. Example of serviceable latching bolt
