# MANDATORY SERVICE BULLETIN

Model DA 40 / DA 40 F / DA 40 D / DA 40 NG

## **MANDATORY SERVICE BULLETIN NO.** **MSB 40-103 / MSB F4-042 / MSB D4-114 / MSB 40NG-084** **REV. 1**

Actions to prevent Passenger Door Separation: Installation of Placards, AFM Procedure update and Inspection/Data Gathering.

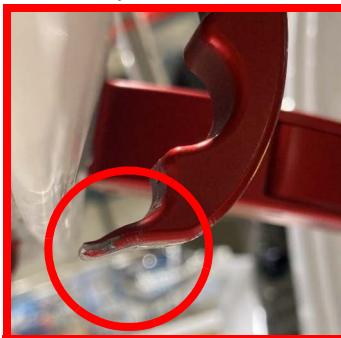
**Not** acceptable condition example:

- b) Examine the hook end of the safety hook.

- The hook end must not be bent.

- h) If the safety hook does not meet one or more of the acceptable conditions listed above on sub-steps **a** through **g**, take note to replace the safety hook after this WI is completed. Refer to Section IV for replacement of the safety hook.

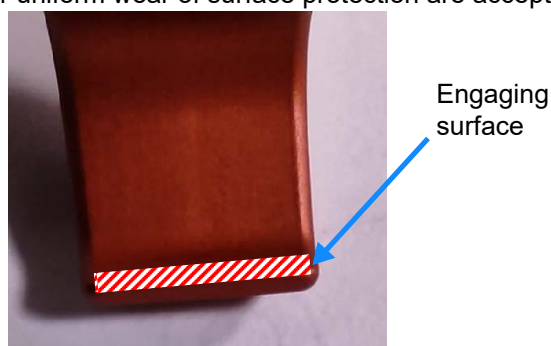
- d) Examine the engaging surface of the safety hook, which is the plane surface at the tip of the safety hook.
- It must not have any steps and ridges.
  - Scratches or uniform wear of surface protection are acceptable.
