**MANDATORY SERVICE BULLETIN NO.**  
**MSB 40-103 / MSB F4-042 / MSB D4-114 / MSB 40NG-084**  
**REV. 2**

Type: DA 40 / DA 40 D / DA 40 F / DA 40 NG

Actions to prevent Passenger Door Separation: Installation of Placards, AFM Procedure update and Inspection/Data Gathering.

**WORK INSTRUCTION**  
**WI-MSB 40-103 / WI-MSB F4-042 / WI-MSB D4-114 / WI-MSB 40NG-084**  
**REV. 2**

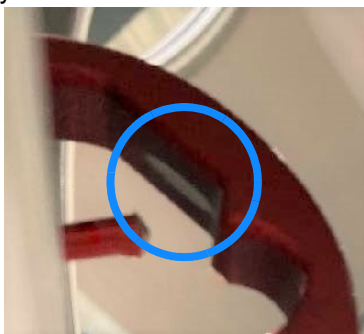
- a) Check the contact area of the push button.
- Grooves in the safety hook must be less than 2 mm deep.

- h) If the safety hook does not meet one or more of the acceptable conditions listed above on sub-steps **a** through **g**, take note to replace the safety hook after this WI is completed. Refer to Section IV for replacement of the safety hook.

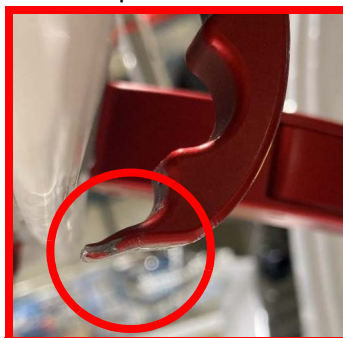
**Not** acceptable condition example:

- b) Examine the hook end of the safety hook.

- The hook end must not be bent.

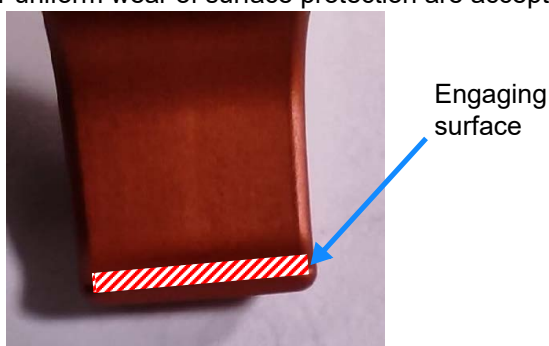
d) Examine the engaging surface of the safety hook, which is the plane surface at the tip of the safety hook.

- It must not have any steps and ridges.
- Scratches or uniform wear of surface protection are acceptable.

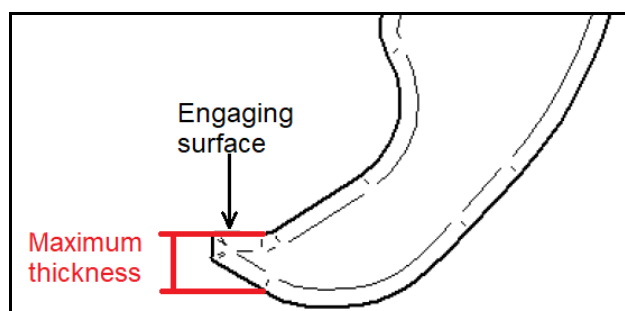
- f) Measure the maximum thickness of the safety hook at the location of the engaging surface, perpendicular to the engaging surface.
- The maximum thickness must be greater than 2.5 mm.
  - The the variation of thickness measured along the width of the safety hook must be less than 0.2 mm.

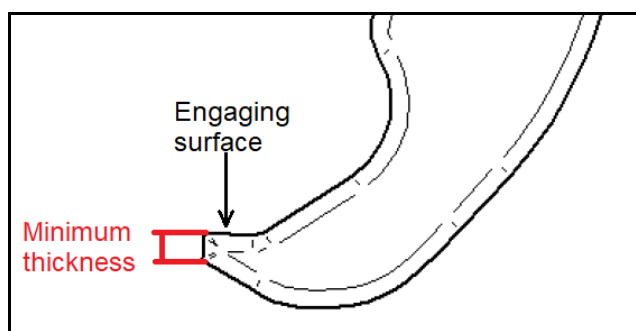
- g) Measure the minimum thickness of the safety hook at the location of the engaging surface, perpendicular to the engaging surface.
- The minimum thickness must be greater than 1.5 mm.
  - The variation of thickness measured along the width of the safety hook must be less than 0.2 mm.

- The edge of the engaging surface of the safety hook that is facing towards the retaining block must not have any ridges.

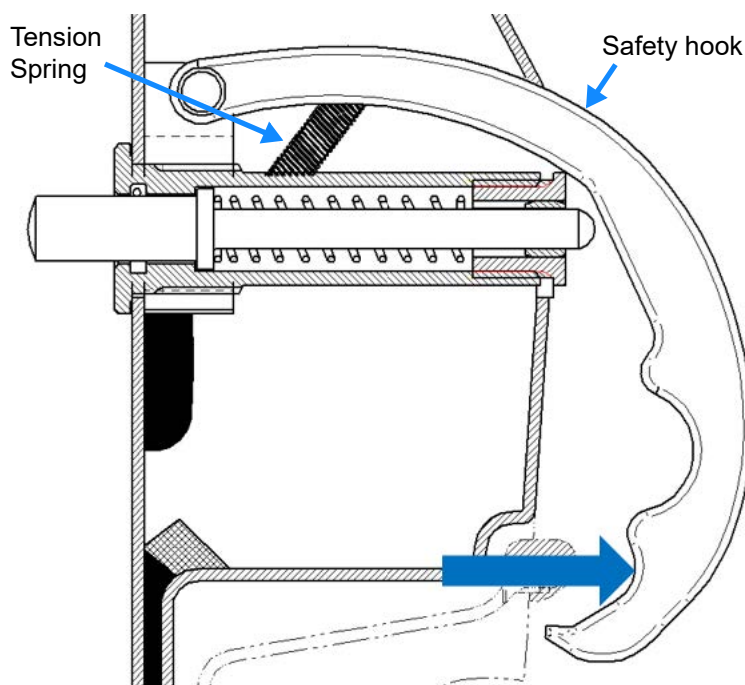
6. Check the condition of the tension spring and the force to lift the safety hook from its resting position as follows:  
Refer to Figure 2.
- Open the passenger door.

- Examine the tension spring of the safety hook. Use a borescope through cutout in the door, if corrosion, deformation or damage is found, take note and replace it after this WI is completed. Refer to Section IV for removal and installation of the hook assembly.

- If correction/replacement of any part is required, take notes and do it after this WI is completed. Refer to Section IV for removal and installation of the hook assembly.

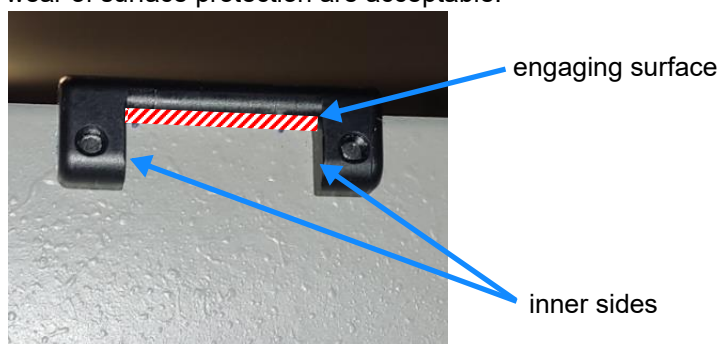
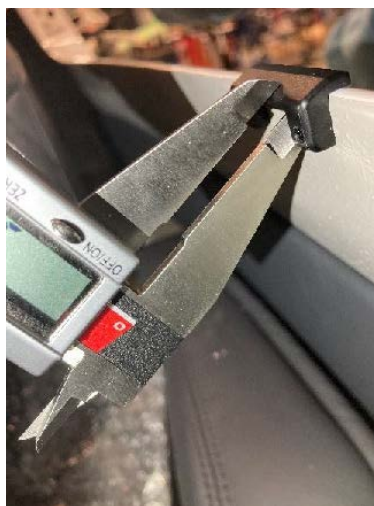
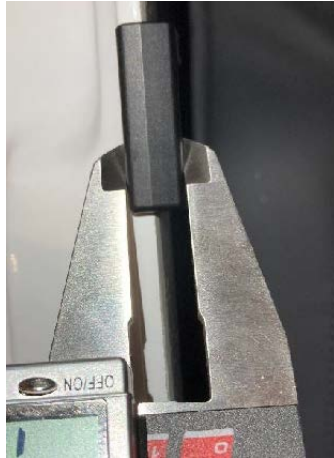
- The thickness of the retaining block measured perpendicular to the upper surface must be greater than:
  - 4 mm for retaining block DA4-5200-00-69\_02 (extended with undercut) or
  - 6 mm for all other retaining blocks. Refer to step 7 for retaining block versions.

- The width of the retaining block must be greater than 10 mm. Refer to Figure 3.
- The variation in thickness of the measured along the width of the retaining block must be less than 0.2 mm.

If the retaining block does not meet one or more of the acceptable conditions mentioned in step 9, take notes and replace the retaining block after the WI is completed. Refer to section IV for removal/installation of the retaining block.

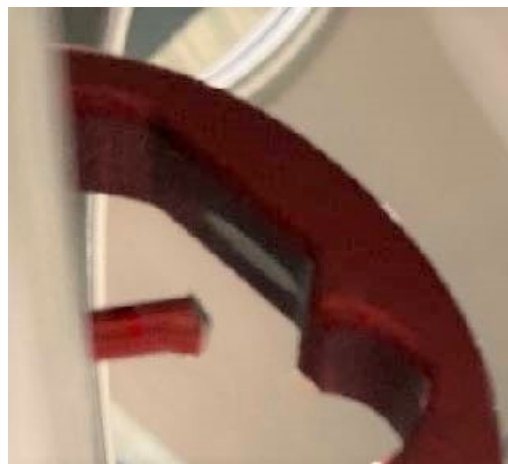
12. Examine the safety hook push button for corrosion, wear and poor condition. Refer to Figure 7.

- There must be no corrosion on the sliding surfaces.
  - If corrosion is found, take note and replace corroded parts after the WI is completed. Refer to Section IV for removal and installation of the push button.
- The play of the push button in the bushing must be less than 1 mm.
  - If the play is greater than 1 mm, take note and replace the affected parts after the WI is completed. Refer to Section IV for removal and installation of the push button.
- Record any findings on the execution report in Appendix A.

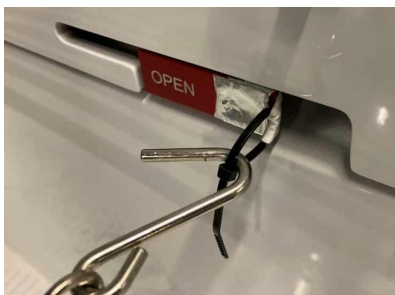
Figure 13. Force measurement example

- a) **Close** and latch the passenger door.
- b) Attach a spring scale with suitable measurement range to the external passenger door handle. Refer to Figure 13.
- c) Measure the force necessary to unlatch the passenger door.
  - The force must be **between** 2 kg (20 N) and 6 kg (60 N).
  - If the force is **greater** than 6 kg (60 N):
    - Identify the reason for exceeding the maximum force limit and rectify any findings.
  - If the force is **less** than 2 kg (20 N):
    - Replace the door sealant (partial) and repeat the test. Refer to section IV.
- d) **Open** the passenger door.
- e) Move the passenger door handle to the latched position.

- f) Measure the force necessary to move the passenger door handle to the unlatched position.
  - The force must be **greater** than 1.8 kg (18 N).
  - If the force is less than 1.8 kg (18 N) and step c) was passed:
    - Replace the gas spring within 12 months. Until then, repeat step c) every 100 hours to ensure force for the **closed** door remains between 2 kg (20 N) and 6 kg (60 N).
  - If the force is less than 1.8 kg (18 N) and step c) cannot be passed:
    - Replace gas spring immediately and repeat step c) and step f).
  - Record the measured forces and any findings on the execution report in Appendix A.
- g) If MÄM 40-139 is not installed (old latching mechanism, refer to step 14) and you fail the tests, replace the metallic spring (Refer to AMM Section 52-10) or replace the old door latch with the new door latch as per RSB 40-093 / RSB D4-105 / RSB 40NG-053.

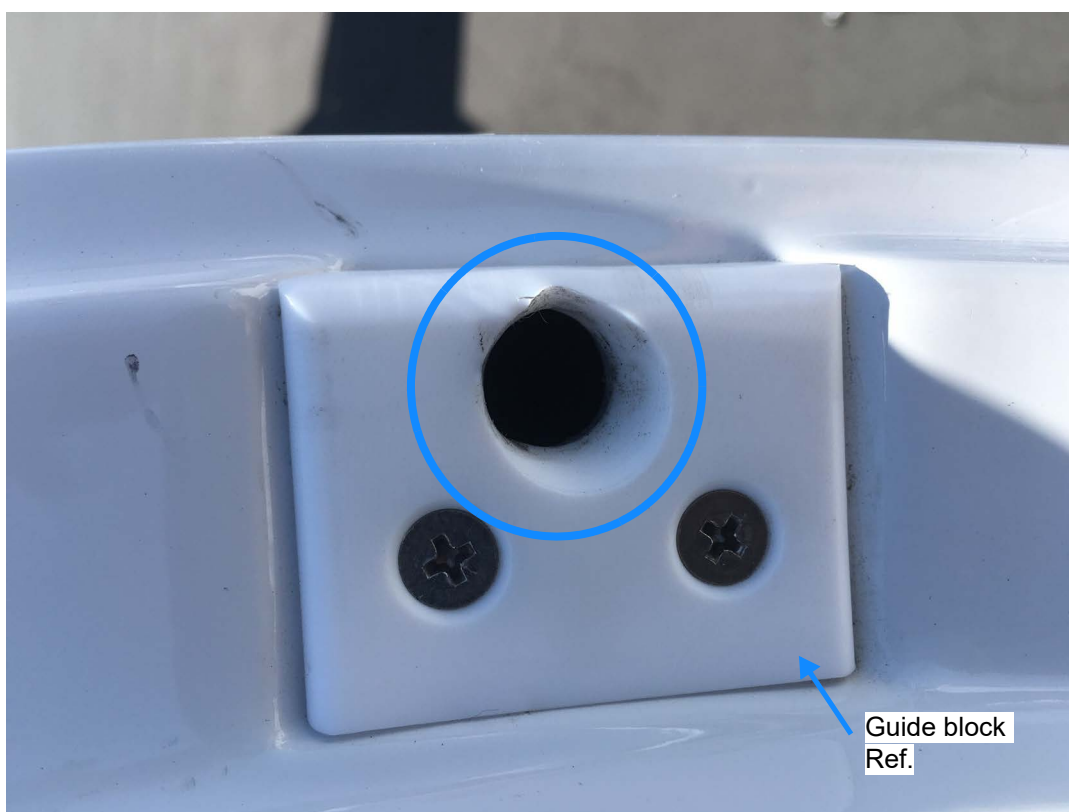
Figure 18. Example of **NOT** acceptable condition of door guide block

23. Inspect the front and rear door guide block for damage. Refer to Figure 18.

- a) Open the passenger door.
- b) Visually check the condition of the guide block.
  - The guide block must not have worn edges, dents, cracks.
  - If you found any damage, take note and replace the guide block after the WI is completed. Refer to section IV for the replacement.
  - Record any damage of the guide blocks on the execution report in Appendix A.

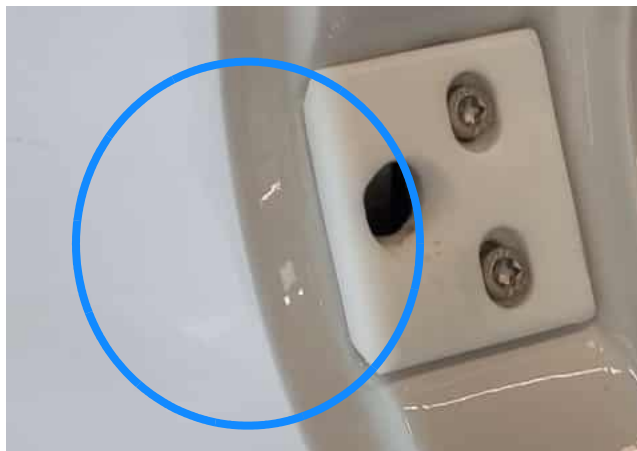
Figure 19. Front

24. Data collection: Inspect the door frame in the area around the front and rear latching bolts for damage. Refer to Figures 19 and 20.
